MARINE DRIVE – PORT ALICE MARINA BRIDGE

2024 BRIDGE INSPECTION

February 8, 2024

Document Code: 24-003A1
Revision: R0

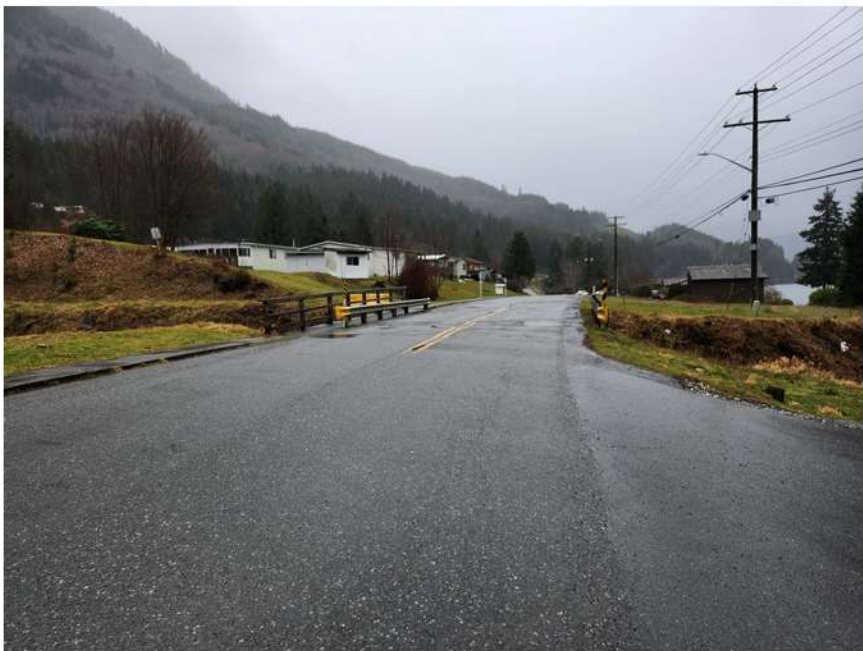
01 - Approach from North Facing South

The bridge approaches have signs of settling at both abutments due to what appears to be settling fill at the girder ends. Additional asphalt appears to have been added to reduce the

dip/impact. Both approaches are free of brush with the corners of the bridge visible, but no standard concrete approach barriers are present.

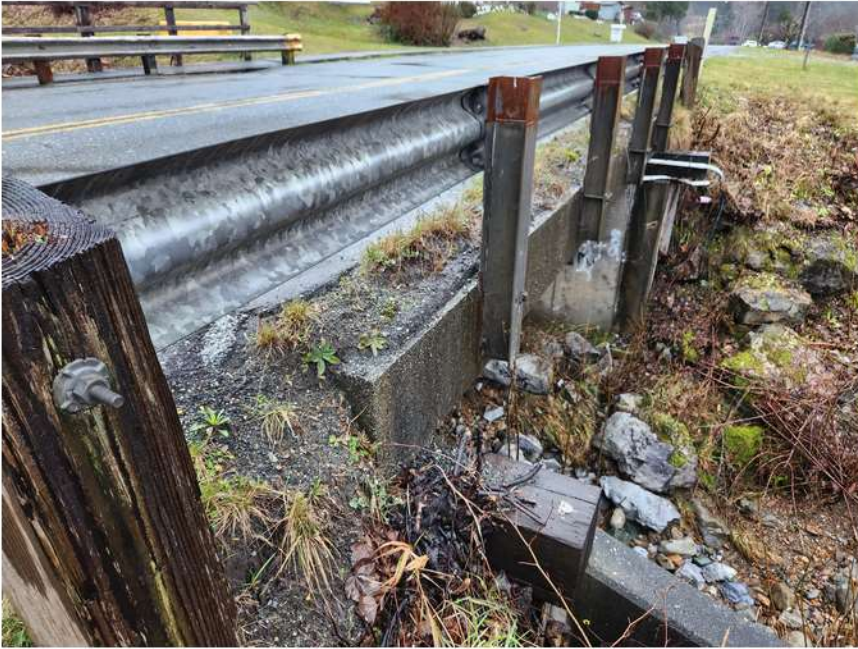
05 - Downstream Barrier

The barrier consists of steel I-section posts bolted to exterior girder flanges are present at both sides of the bridge with additional poorly constructed butt welded I-sections raising the height of the post. Guard rail consists of flexible W-beam with timber posts at either end of the bridge. The guard rail is not connected to approach barriers.

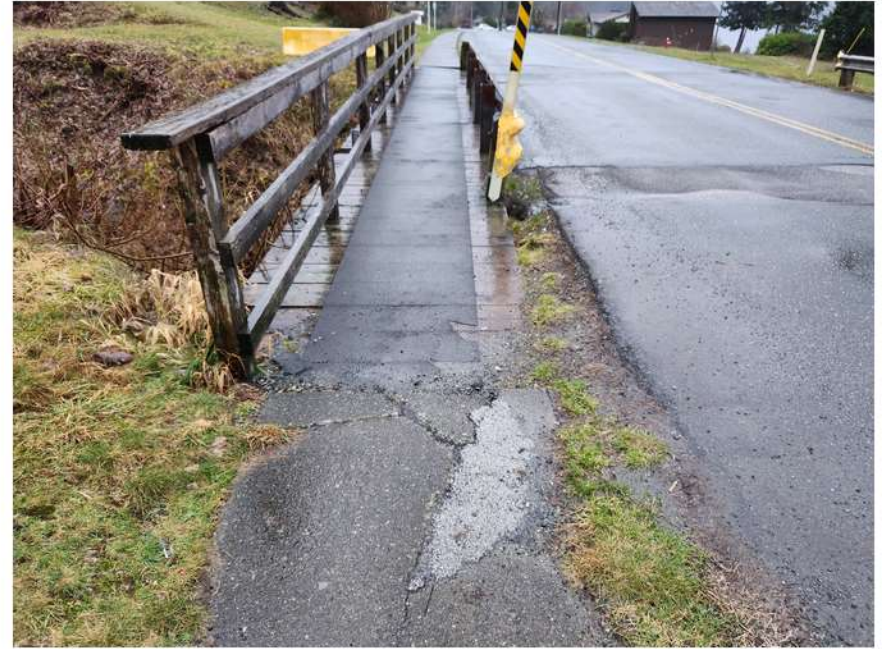
06 - Upstream Barriers

The upstream guard posts are extended below the girder to allow a cantilevered steel I-section to support the timber plank pedestrian walkway. These guard posts will reduce the overall hydraulic clearance due to their height below the soffit of the girders.

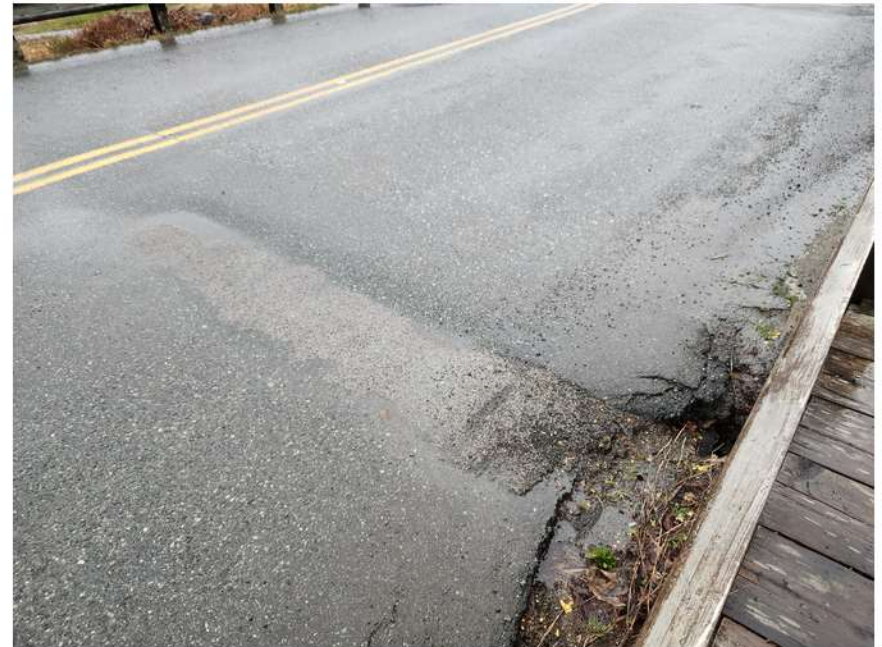
The abutments do not have wide enough return walls extending back into the banks, this has caused the fill slopes within this region to become over steepen and cause settlement and raveling of the banks.

Approaches have settled relative to bridge which apparent by asphalt patches at both approaches. This is likely due to very steep embankment fills. Either side of wing wall returns.

08 - Fill Settling Sound Abutment

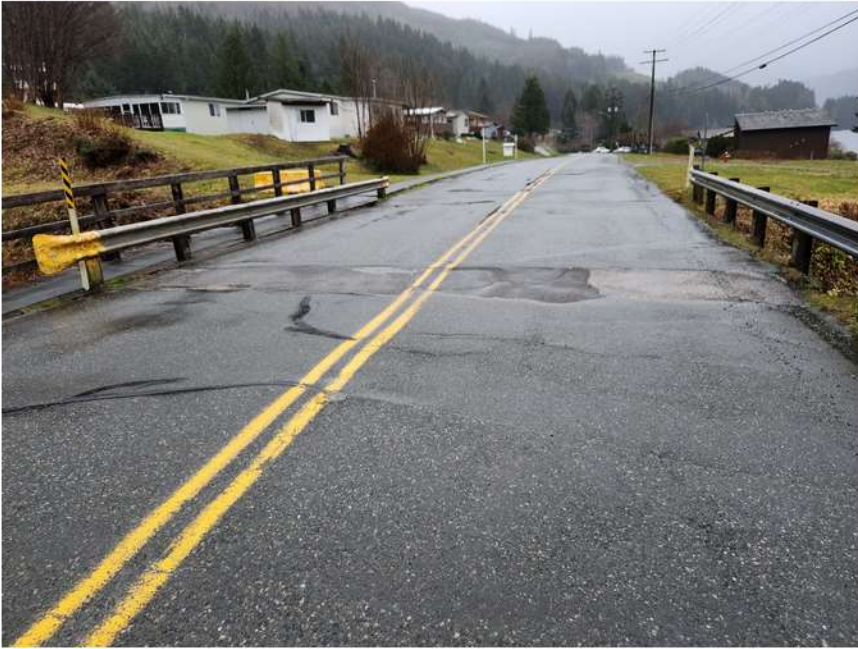
09 - Fill Settling North Abutment

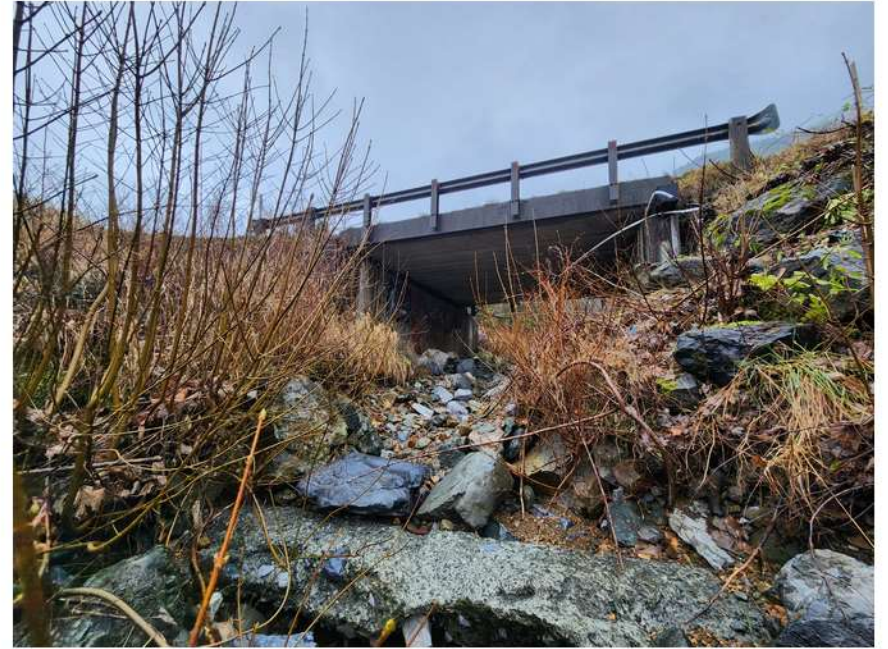
The abutments appear stable, but the riprap along both abutments is minimal with some riprap movement exposing the concrete footing. There is a moderate chance of scouring the footings and should continue to be monitored. The channel appears to have incised at the outlet with a riprap weir noticeable, scour of this riprap weir could undermine the downstream side of the footings destabilizing the bridge potentially requiring closure.

Riprap and embankment slopes very steep and inlet and outsides of bridge abutments.
A large gradient change “weir” is noticeable at outlet by natural channel agradation, this is causing near vertical banks downstream approx 5 to 20m downstream, banks should be pulled back to stabilize slopes and armoured with riprap.
Riprap and creek scour should be monitored as footings as susceptible to scour and settlement.

10 - Downstream Riprap Weir

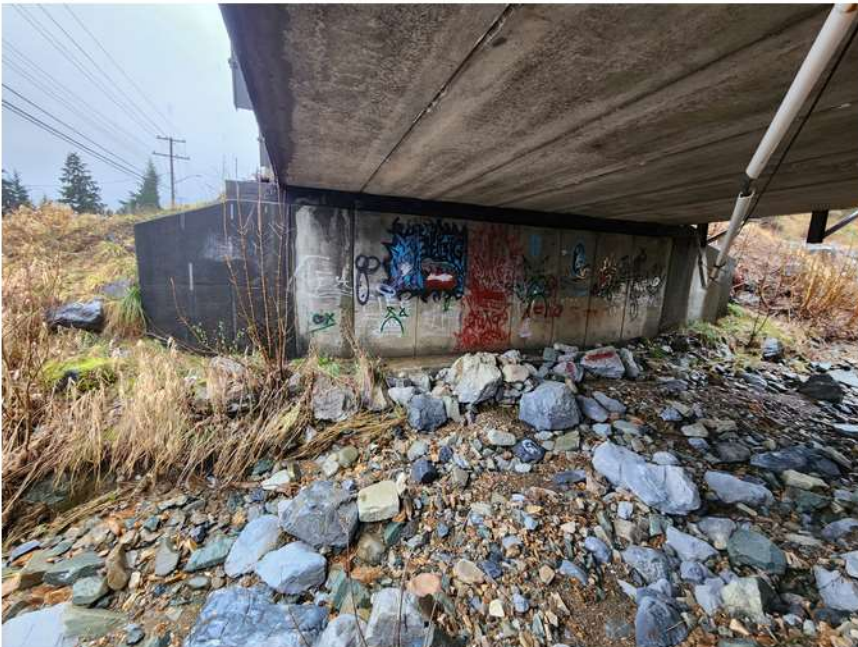
11 - North Abutment

The cast-in-place concrete inverted T-footing abutments are in good condition with no indication of settlement or cracking. The treated 300mm x 300mm timber cap is in fair condition with minimal checking or rot at ends.

Minimal riprap is present along the bridge footings with the downstream end of both abutment footings exposed. The thickness of the abutment footing is unknown and is susceptible to scour and frost heave.

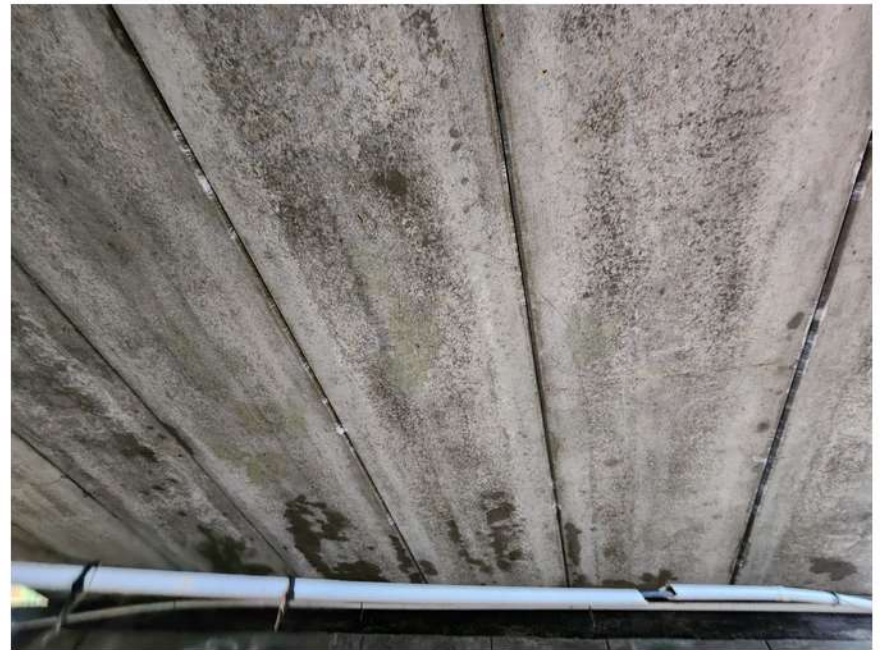
13 - Typ. Girder Spofit

The girders are generally in good condition, there are no signs of cracking, joint seepage or efflorescence which can be an indicator of water seepage within cracks. Record drawings should be located to confirm load rating.

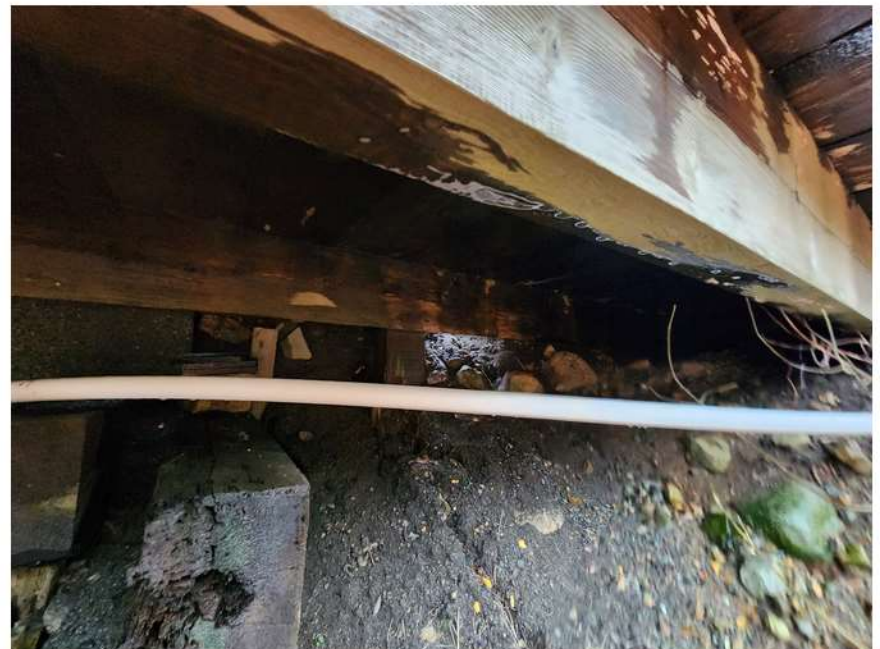
15 - Walkway Stringers

The pedestrian walkway is supported by untreated D.Fir timber stringers and transverse plank decking. The timber stringers are in poor condition and the plank decking is in poor condition. Barrier height between road and pedestrian walkway is lower than MOTI specified.
