# MARINE DRIVE – PORT ALICE MARINA BRIDGE

**2024 BRIDGE INSPECTION**

**February 8, 2024**

# MARINE DRIVE – PULP MILL BRIDGE

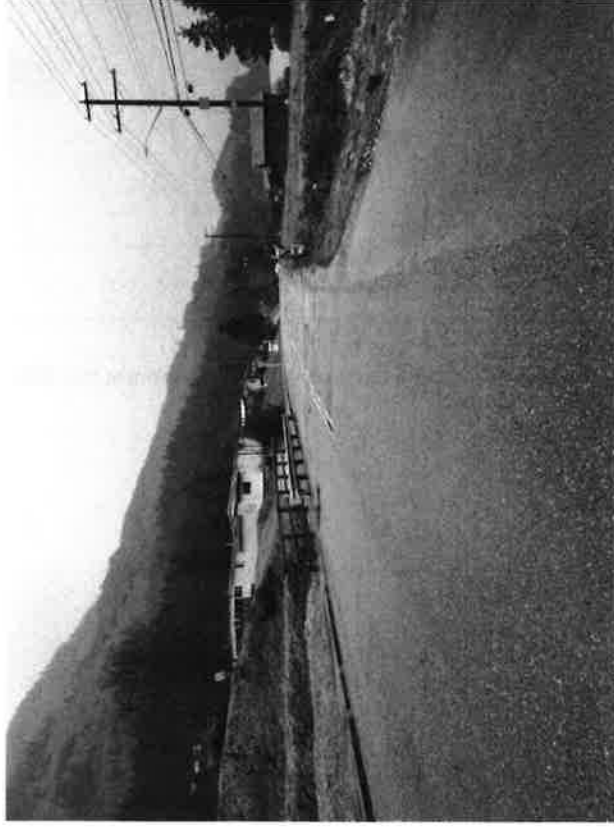
01 - Approach from North Facing South

The bridge approaches have signs of settling at both abutments due to what appears to be settling fill at the girder ends. Additional asphalt appears to have been added to reduce the

dip/impact. Both approaches are free of brush with the corners of the bridge visible, but no standard concrete approach barriers are present.

Item No.	Description	Priority
1	Install concrete approach barriers on all bridge approaches (upstream and downstream sides of bridge).	High
2	Stabilize raveling banks at corner of bridge through additional retaining walls.	Low
3	Replace pedestrian plank decking and stringers and handrails.	Moderate
4	Raise barrier rail height between pedestrian and vehicle to meet MOTI combination pedestrian/vehicle specifications.	High
5	Install MOTI specified delineators at all corners of the bridge.	High
6	Replace rotting timber posts supporting W-beam flex railing at ends of bridge within approach fill.	Low
7	Upgrade barrier system to meet current MOTI standards and integrate with approach barriers.	Moderate
8	Locate bridge record drawings	Low

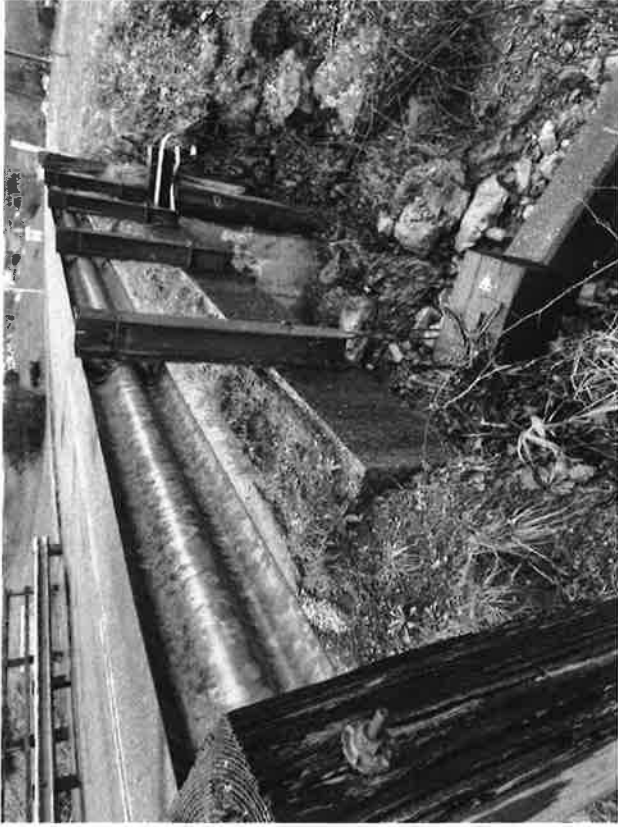
05 - Downstream Barrier

The barrier consists of steel I-section posts bolted to exterior girder flanges are present at both sides of the bridge with additional poorly constructed butt welded I-sections raising the height of the post. Guard rail consists of flexible W-beam with timber posts at either end of the bridge. The guard rail is not connected to approach barriers.

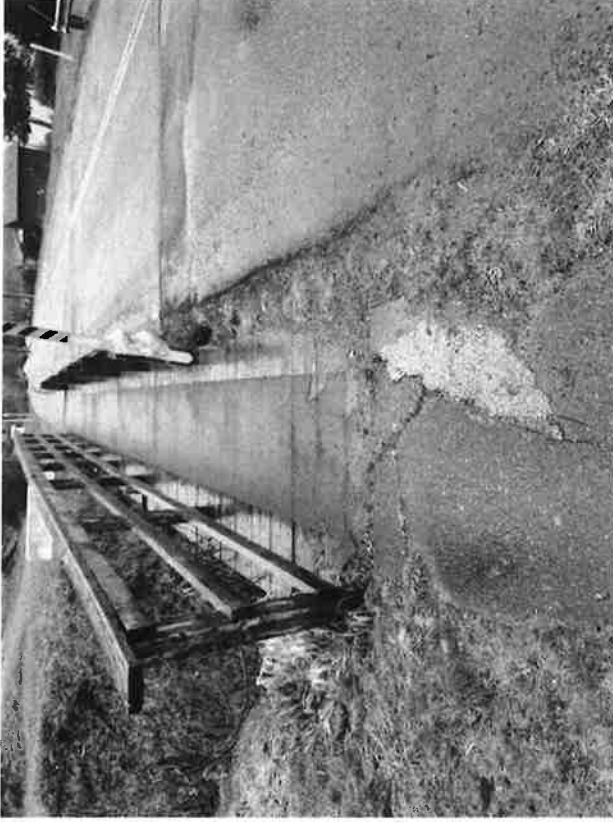
06 - Upstream Barriers

The upstream guard posts are extended below the girder to allow a cantilevered steel I-section to support the timber plank pedestrian walkway. These guard posts will reduce the overall hydraulic clearance due to their height below the soffit of the girders.

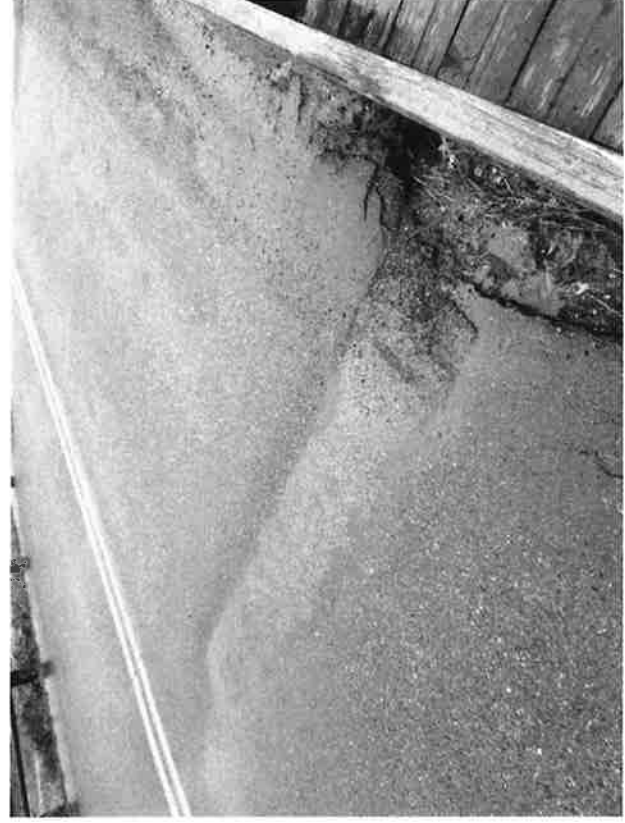
08 - Fill Settling Sound Abutment

The abutments do not have wide enough return walls which has led to over steepened fill slopes adjacent to the abutment which has led to bank scour and could be a contributing factor to the approach settlement noted in the road surface.

The abutments do not have wide enough return walls extending back into the banks, this has caused the fill slopes within this region to become over steepen and cause settlement and raveling of the banks.

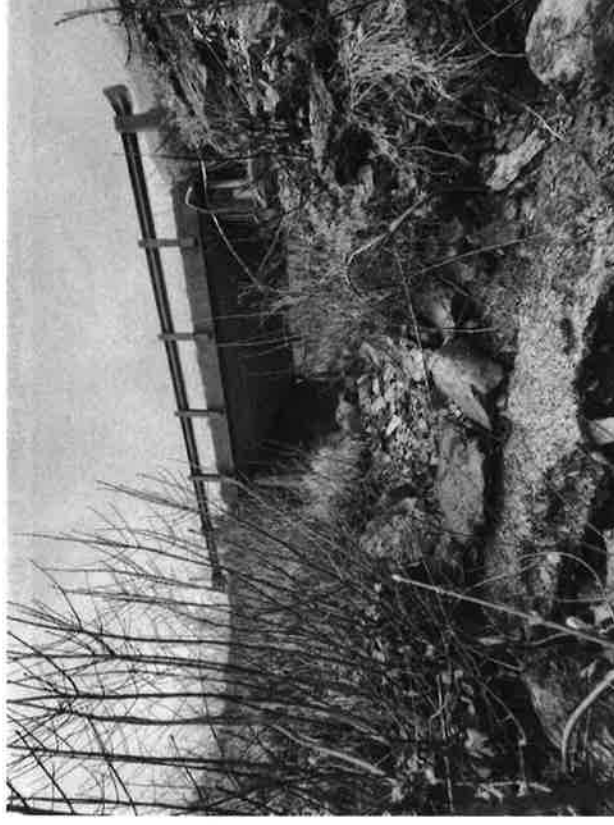
10 - Downstream Riprap Weir

<b>Item No.</b>	<b>Description</b>	<b>Priority</b>
1	Scour at left and right bank abutments	Moderate
2	Scour at riprap weir downstream	Low
3	Approach settlement at girder ends	Low

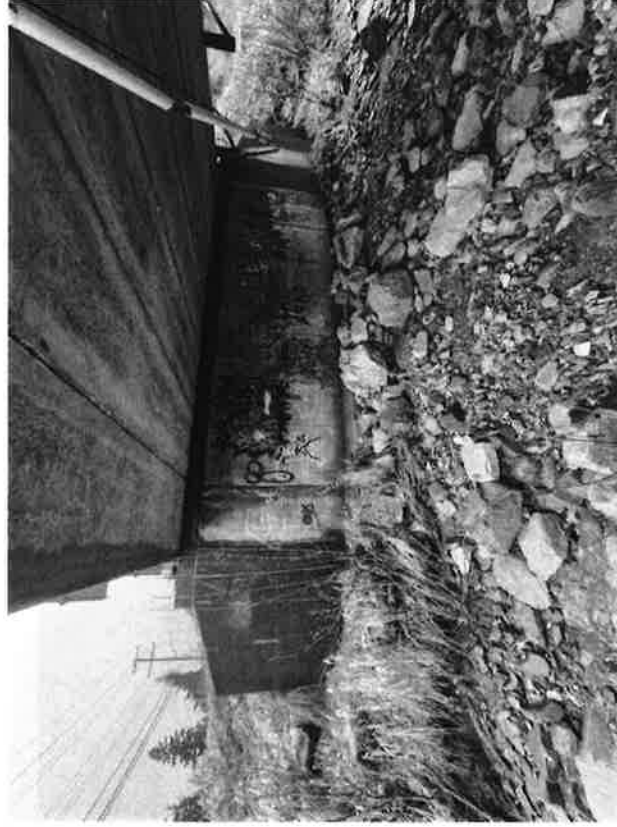
11 - North Abutment

The cast-in-place concrete inverted T-footing abutments are in good condition with no indication of settlement or cracking. The treated 300mm x 300mm timber cap is in fair condition with minimal checking or rot at ends.

Minimal riprap is present along the bridge footings with the downstream end of both abutment footings exposed. The thickness of the abutment footing is unknown and is susceptible to scour and frost heave.

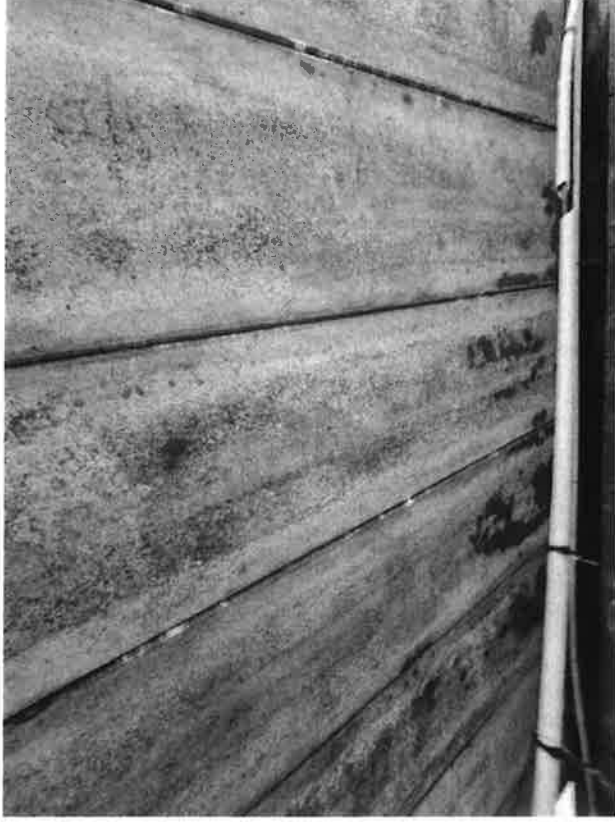
13 - Typ. Girder Spoff

The girders are generally in good condition, there are no signs of cracking, joint seepage or efflorescence which can be an indicator of water seepage within cracks. Record drawings should be located to confirm load rating.

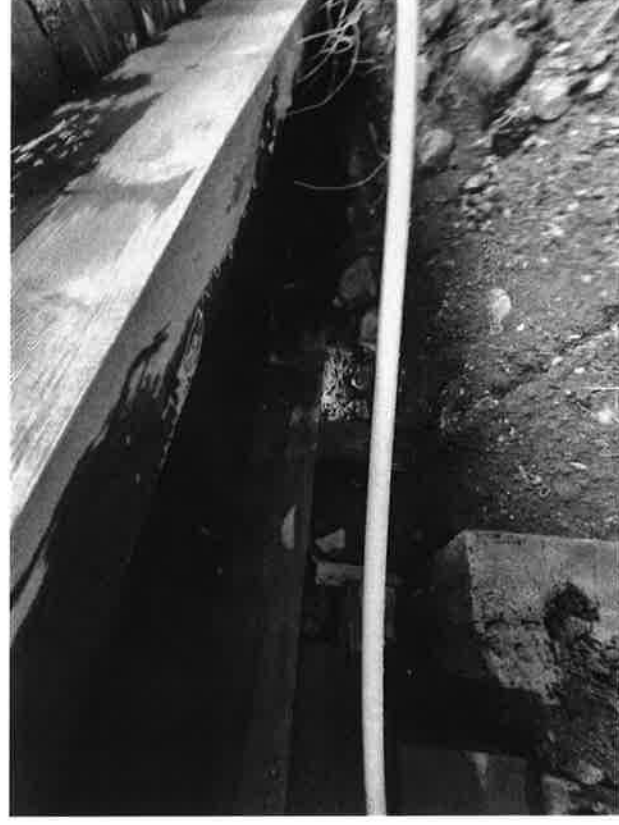
15 - Walkway Stringers

The pedestrian walkway is supported by untreated D.Fir timber stringers and transverse plank decking. The timber stringers are in poor condition and the plank decking is in poor condition. Barrier height between road and pedestrian walkway is lower than MOTI specified.

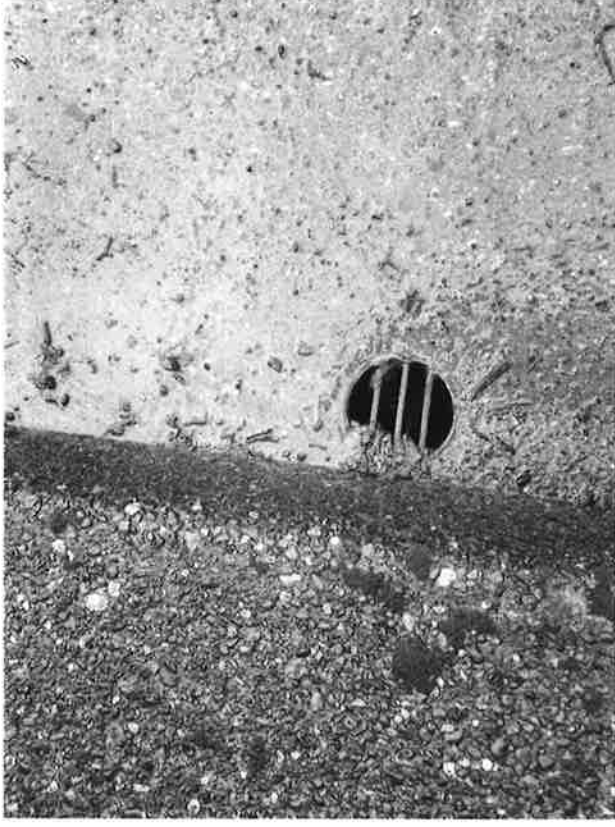
06 - Deck Drain, Typ.

The bridge does not have an asphalt overlay, but the cast-in-place deck makes up the traveled surface and is in good condition. Deck drains are located throughout the structure on either side of the bridge adjacent to the elevated curb. At the time of inspection multiple deck drains were plugged with sediment, these drains partially cleaned during the inspection. Routine maintenance should be cleaning the deck drains and bearings.

<b>Table 1 – List of Maintenance / Repair Items</b>		
<b>Item No.</b>	<b>Description</b>	<b>Priority</b>
1	Replace timber end posts for barrier railing	Moderate
2	Clean deck and drains of sediments	Low

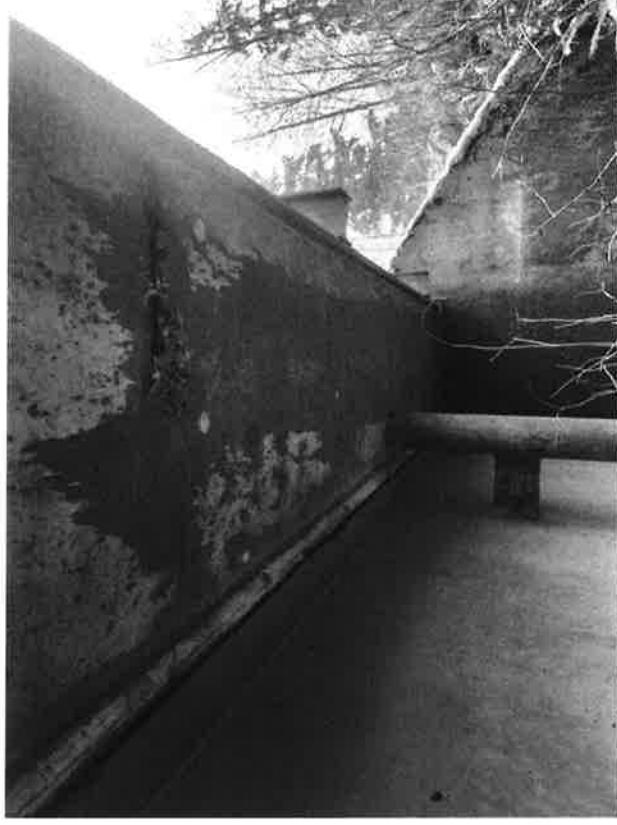
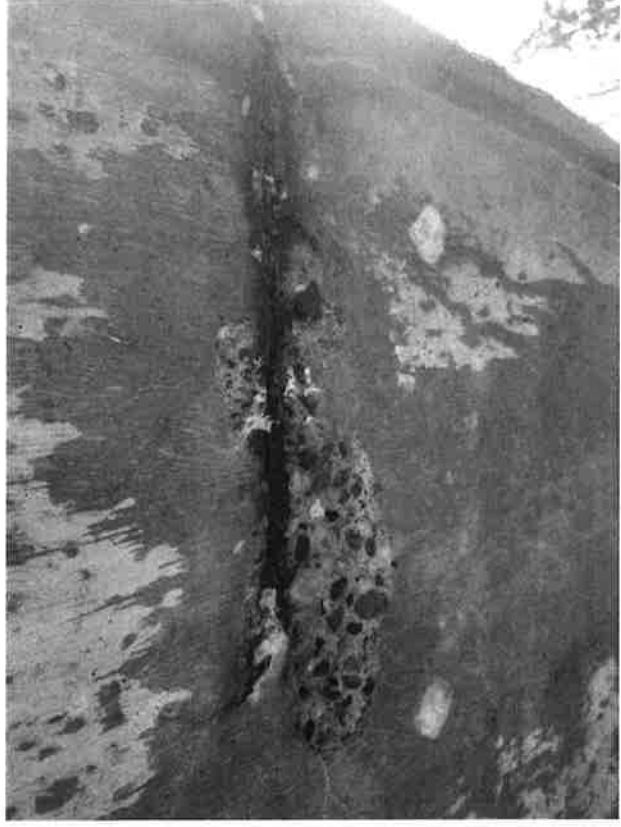
09 - Rebar Corrosion

On the downstream side of bridge, 3m from the south abutment exposed rebar was noted on the soffit of the cantilevered portion of the deck, this rebar has begun to corrode and spall concrete along the length of corrosion. This should be repaired to prevent further rebar corrosion and concrete spalling.

3	Installed standard MOTI delineators	Moderate
4	Repair asphalt and ends of bridge at concrete deck	Moderate
5	Clean and repair exposed rebar on underside of deck	Moderate
6	Clean, prepare and re-coat bearing plates	Low

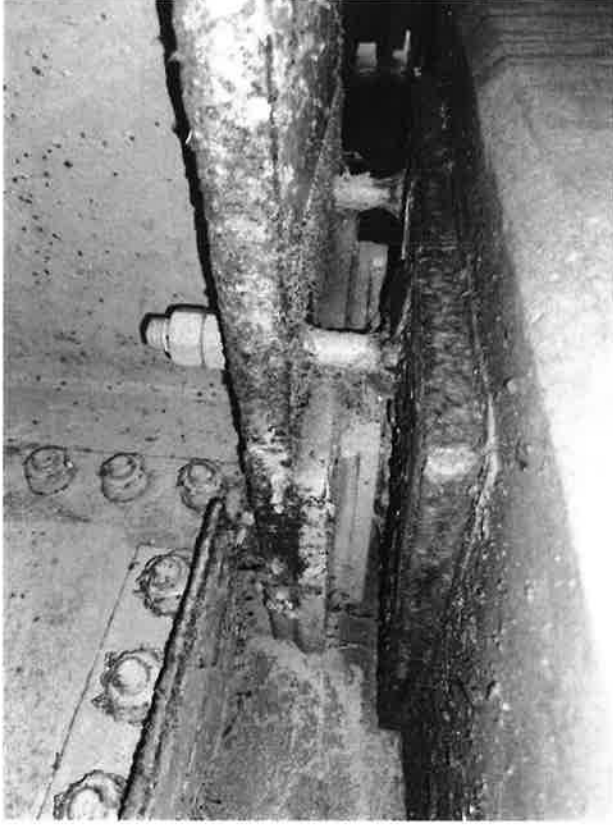
12 - Typical Bearing Corrosion

The bearing masonry and sole plates are poorly coated with exposed steel. The exposed steel is rusting and starting to flake of coating and steel material. These steel plates should be sufficiently cleaned, prepared, and re-coated to prevent bearing replacement or further corrosion.

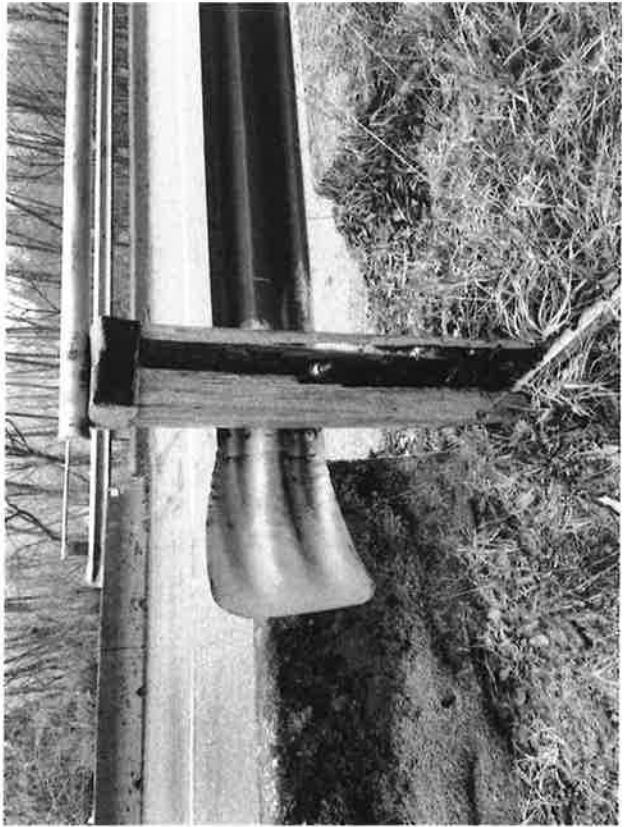
17 - Rotten End Posts

Timber end posts for the W-beam barrier railing are rotten and should be replaced.
