## Building Condition Assessment

# Port Alice / Doug Bondue Arena

05 November 2025

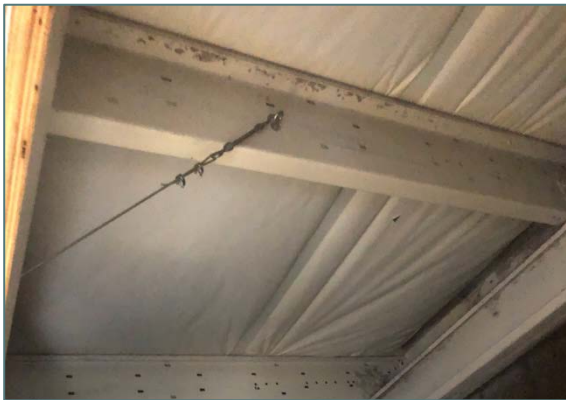
There are two different approaches to roof insulation. Most of the facility has an insulating layer installed above the structural purlins and below the sheet metal roofing. This insulation layer is a blanket type, with a poly surface facing the interior.

Figure 1: Roof insulation, blanket type

The thermal resistance of each of these layers is minimal. I would estimate the R-value of the combined system to be less than R-5.

- Inspect the cavity between the foil faced bubble wrap insulation and the above purlins to confirm moisture levels are not increased in this area.
- Provide a level of heating and ventilation suitable to prevent interior moisture damage.
- Monitor rainwater management system to ensure continued functionality.
- Adding insulation to the roof and walls could be considered if a change of use requires a heated space (higher level of space conditioning).

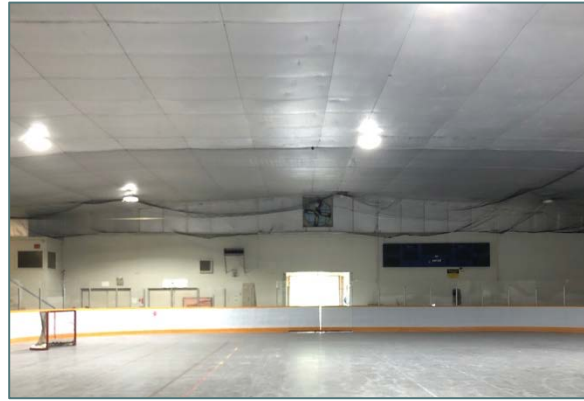
Figure 3: Roof insulation, bubble wrap type

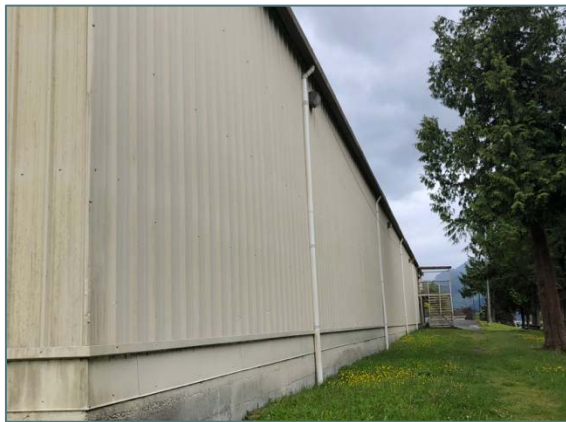
The arena's exterior walls are composed of corrugated sheet metal panel, wood stud infill between steel primary structure, with plywood interior surface. Insulation was not observed, but review of the original drawings shows 2" of insulation placed against the inside surface of the siding.

The thermal resistance of the exterior walls is minimal. I would estimate the R-value to be less than R-5.

Figure 4: Exterior corrugated metal siding

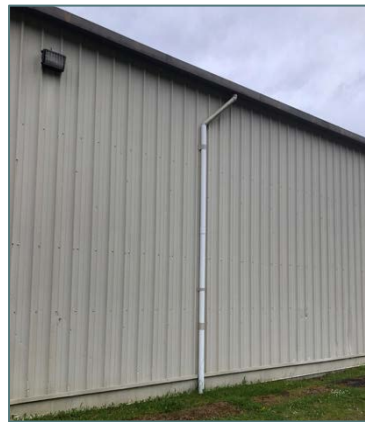
Figure 5: Gutter & Downspout

The rainwater management system, including gutters, down spouts and connection to below grade drainage appears fully intact and functional.

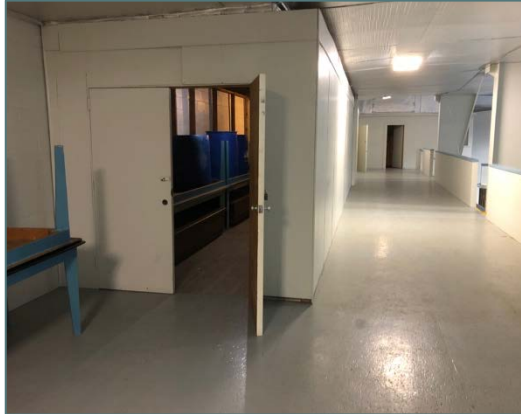
Figure 6: Concourse Storage Area

It appears these additions have not been built according to building code requirements and seems unlikely they were approved by the regional building inspector.

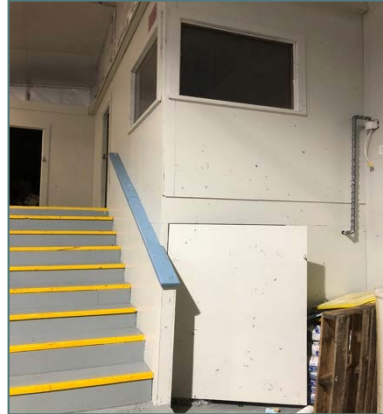
Figure 7: Music Booth & Storage

- Professional testing of interior existing glass panels to confirm they meet building code requirements for safety glass.
- Remove glazing in the rink announcer's booth and the music booth if it doesn't meet building code requirements. It has been recommended earlier in this assessment that these additions be removed entirely. The glazing could be included in this removal.

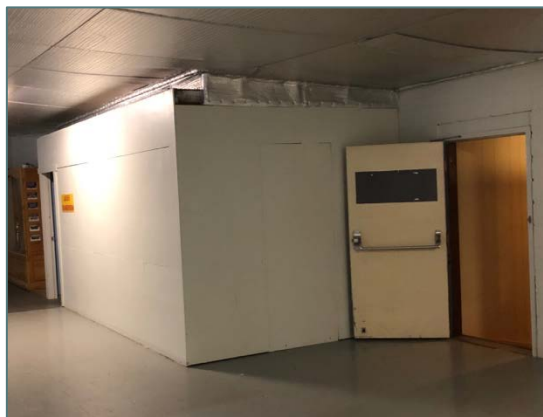
Figure 8: Concourse Change Room

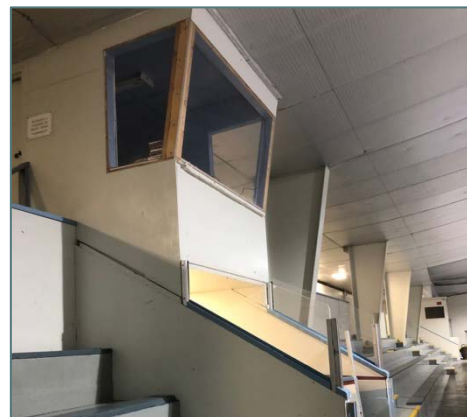
Figure 9: Announcers Booth

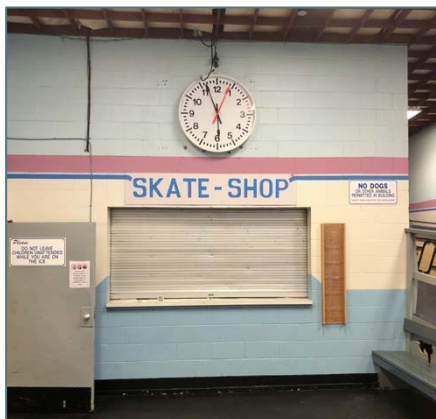
An interior demising fire wall divides the arena building roughly in half. Running north / south and located on the east side of the curling surface, it jogs near the south end to include the lobby and the rink main access ramp. It separates the lobby, offices, curling lounge, curling surfaces; from the skating rink, rink concourse, and change rooms. This vertical fire separation is constructed of concrete block (CMU). Openings in this wall should be protected with the appropriate doors and automatic closers. Service penetrations should be appropriately sealed.

Figure 10: CMU fire wall

- Review requirements for doors in fire wall. Replace if non-conforming.
- Confirm doors in fire wall have operational automatic door closers.

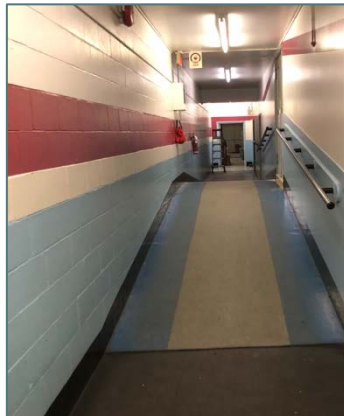
Figure 11: CMU fire wall

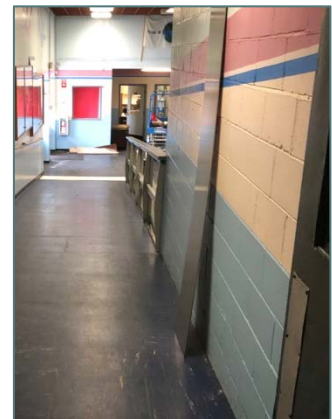
Figure 12: CMU fire wall

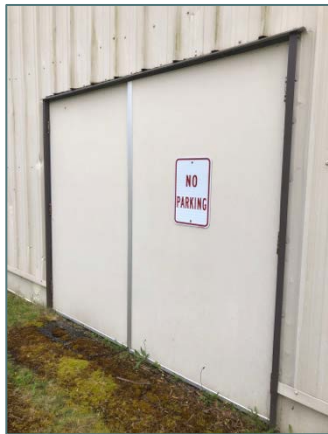
A visual and manual inspection of exiting revealed many of the exit doors are marginally functional or non-functional. Each exit door will need to be reviewed for full functionality, including panic hardware, free swinging operations, and re-latching after opening. Required signage and emergency lighting also need to be reviewed. This is covered in the Electrical Systems Assessment section.

Figure 13: Exit

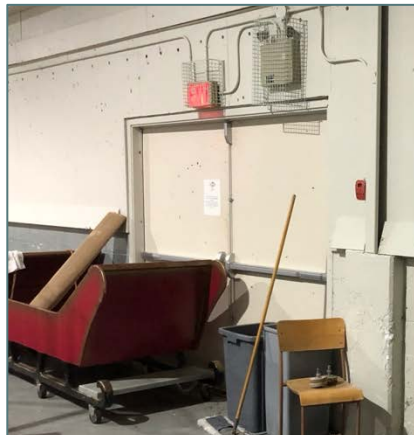
In the site visit and review of the building it was noted that some portions of the building were being used for storage. The use as a general storage facility is not acceptable under the current Assembly use, except for rooms or spaces specifically designed for this purpose. Also noted was stored items in on egress routes hindering access to exits.

Figure 14: Exit w/storage

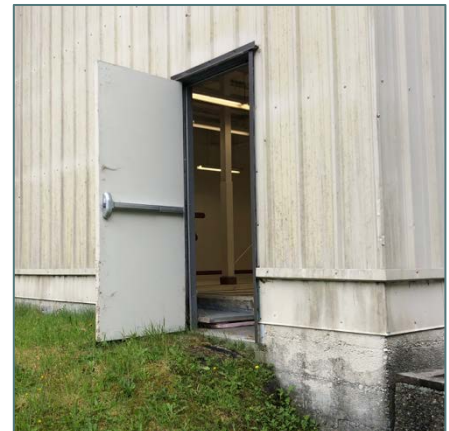
Figure 15: Exit

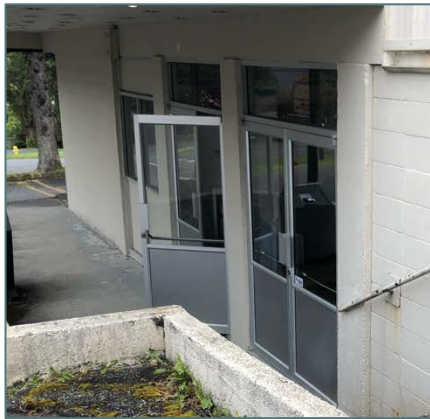
Exterior aluminum and glass entry doors at the lobby were observed to be glazed with safety glass.

Figure 16: Glazed Entrance Doors

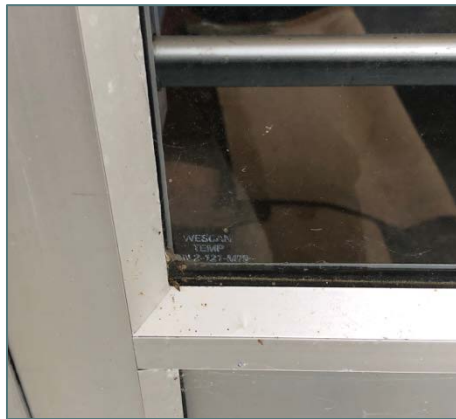
Figure 17: Tempered Glass Marking

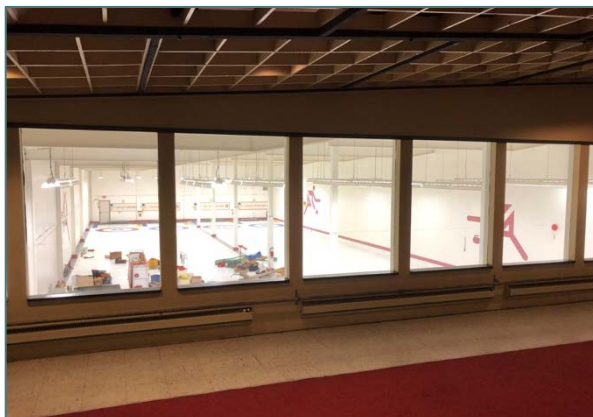
Interior glazing can be found between the curling surface and the adjacent viewing area; and at level two in the lounge, overlooking the curling surface. Both locations require safety glass. The glass panels observed did not have the glazing type noted.

Figure 18: Glazing at Lounge Viewing

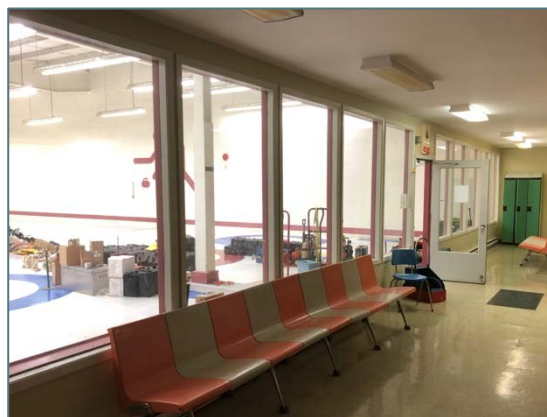
Figure 19: Glazing at Curling Surface

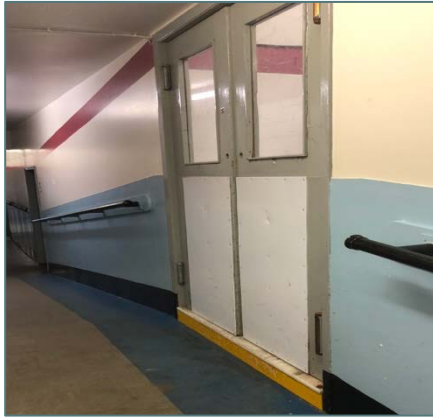
Other interior glazing can be found at interior double swing doors. These areas also require safety glass. It was observed that some doors had glass and some had plexi-glass or other type of transparent acrylic product.

Figure 20: Glazing at interior doors

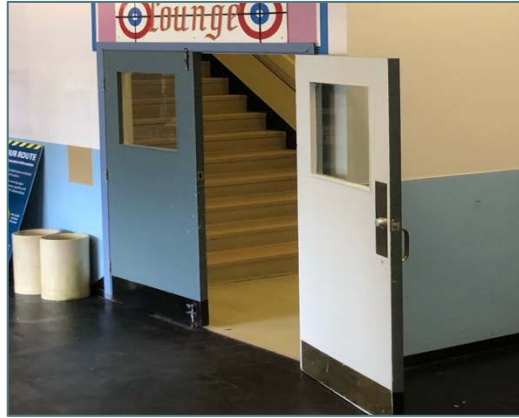
Figure 21: Glazing at interior doors

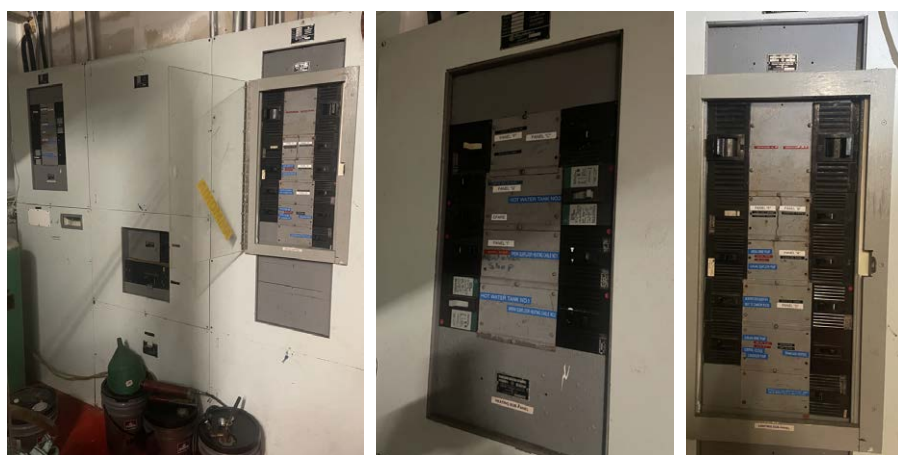
The facility is serviced via an underground BC Hydro 1200 Amp, 120/208 Volt, three phase service from a BC Hydro pole on the opposite side of Marine Drive, via a BC Hydro Padmount Transformer (size unknown). The Mechanical/Electrical Room houses the service entry and main switchboard, which comprises of a 1200 Amp main breaker, which then splits off to two smaller breakers: 800 Amp for the Lighting Sub-Panel & 400 Amp for the Heating Sub-Panel, both of which are part of the main switchboard (see Figure 1). The main switchboard and sub-panels are all Canadian General Electric. There is a BC Hydro Meter & C/T for each of these two sub-feeds.

**Figure 1: Canadian General Electric 1200 Amp Main Switchboard, 800 Amp Lighting Sub Panel & 400 Amp Heating Sub Panel**

The Canadian General Electric main switchboard and panels are legacy equipment and have exceeded their BOMA recommended life cycle of 30 years. Sourcing new breakers for this equipment could be an issue.

- Replacement of those electrical panels where rusting is an issue.
- Replacement of Canadian General Electric main switchboard and panels, if sourcing new breakers is not possible.
- Provide lamicon label on all electrical panels to include panel name, voltage, amperage, and phase.

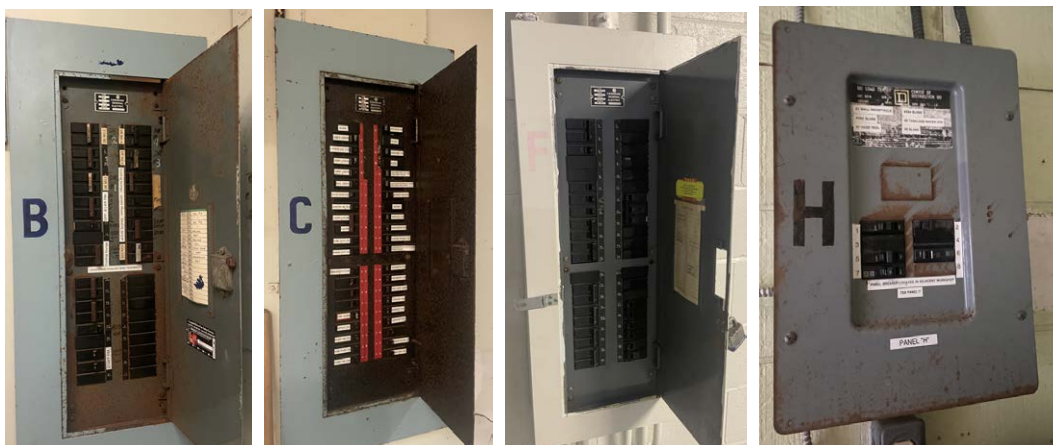
The two sub-panels provide feeds to several distribution panels throughout the facility, which are mostly Canadian General Electric, with a couple of Square D panels (see Figure 2). Most appear to be in reasonable condition, except for some rusting noted on several of them, and most are physically full.

**Figure 2: Examples of Distribution Panels; Evidence of Rusting**

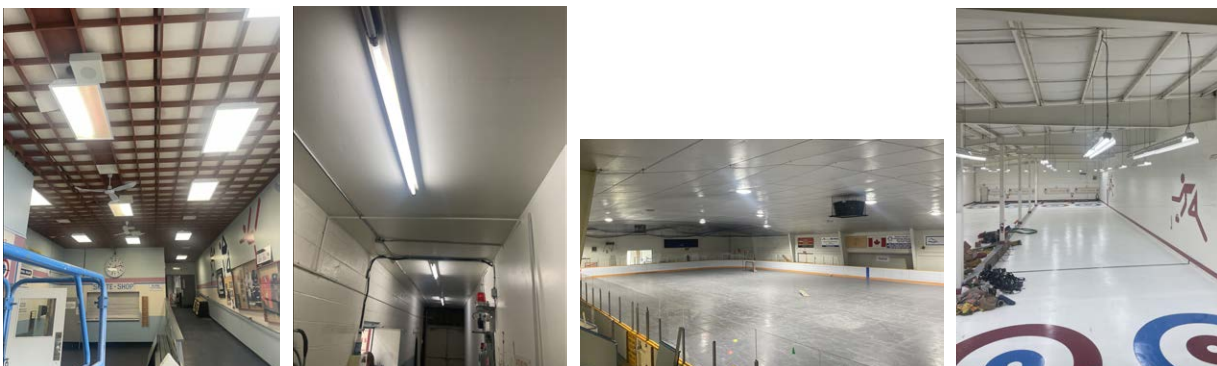
The interior lighting fixtures are a mixture of LED and fluorescent fixtures, with evidence of retrofit LED lamp installations throughout (see Figure 3). Lighting controls consist primarily of local toggle switches, along with some dimming and motion switches. Motion switches were found to be installed in each of the washrooms and changerooms, however, there were several examples where the motion switch was not operating, and hence, the light fixtures did not function. Corridor lighting is controlled by toggle switches.

**Figure 3: Examples of Interior Light Fixtures**

- Replace the remaining interior fluorescent lights with LED.
- Replace existing exterior incandescent lights with LED.

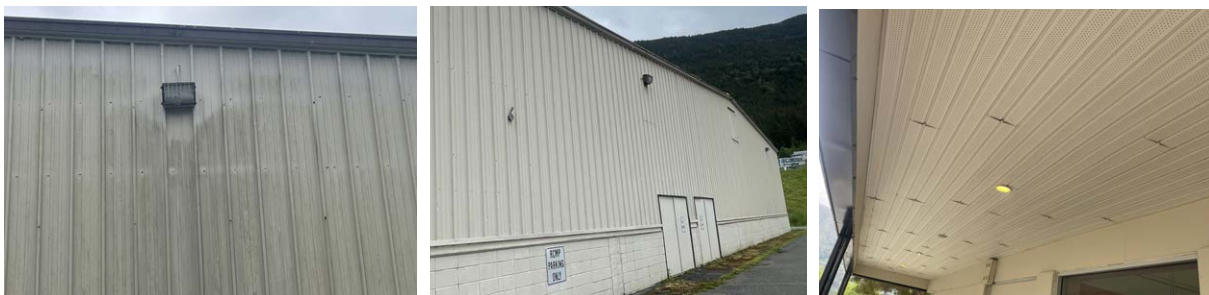
Exterior lighting consists of incandescent perimeter lighting and LED canopy fixtures (see Figure 4). Exterior lighting controls is by photocell.

**Figure 4: Examples of External Light Fixtures & Photocell**

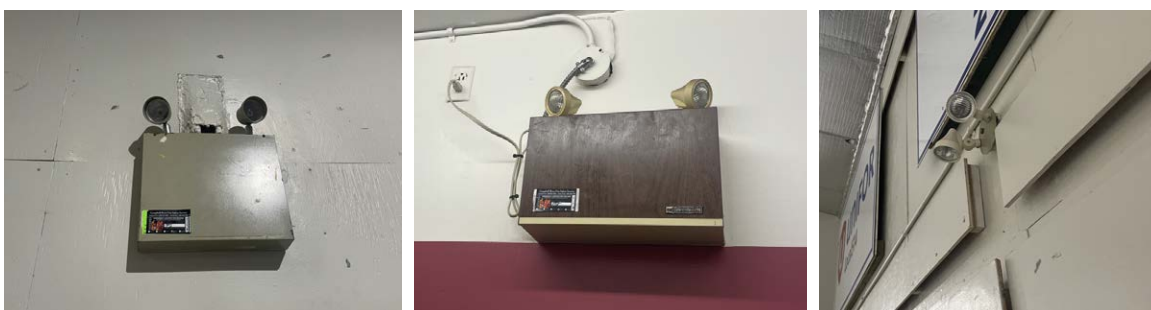
Emergency lighting consists of double-head incandescent fixtures complete with battery pack, supplemented by double head incandescent remote fixtures (see Figure 5). The last test of the devices was in 2018. Coverage throughout the facility was observed to be inadequate, and therefore, not compliant with the latest BCBC emergency lighting requirements. None of the washrooms or changerooms had emergency lighting installed, and areas such as the main entrance did not have any installed.

**Figure 5: Examples of Emergency Lighting**

- Replace existing emergency lighting with LED; add supplementary LED emergency lights throughout the facility to ensure coverage as per the latest BCBC requirements.
- Add emergency lights to all washrooms and changerooms.
- Replace exit signs throughout the facility with green running man; add supplementary exit signs throughout the facility to ensure coverage as per the latest BCBC requirements.

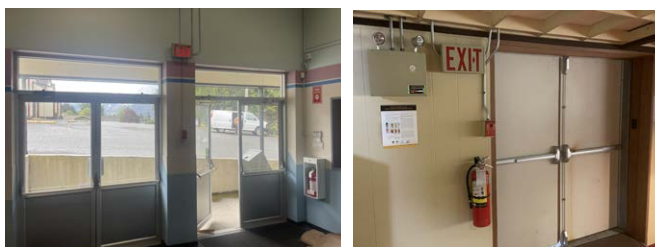
All the exit signs throughout the facility are the old-style red lettering (see Figure 6) and not the green running man signs as per the latest edition of the BCBC. Coverage throughout the facility was observed to be inadequate as per the latest BCBC emergency lighting requirements.

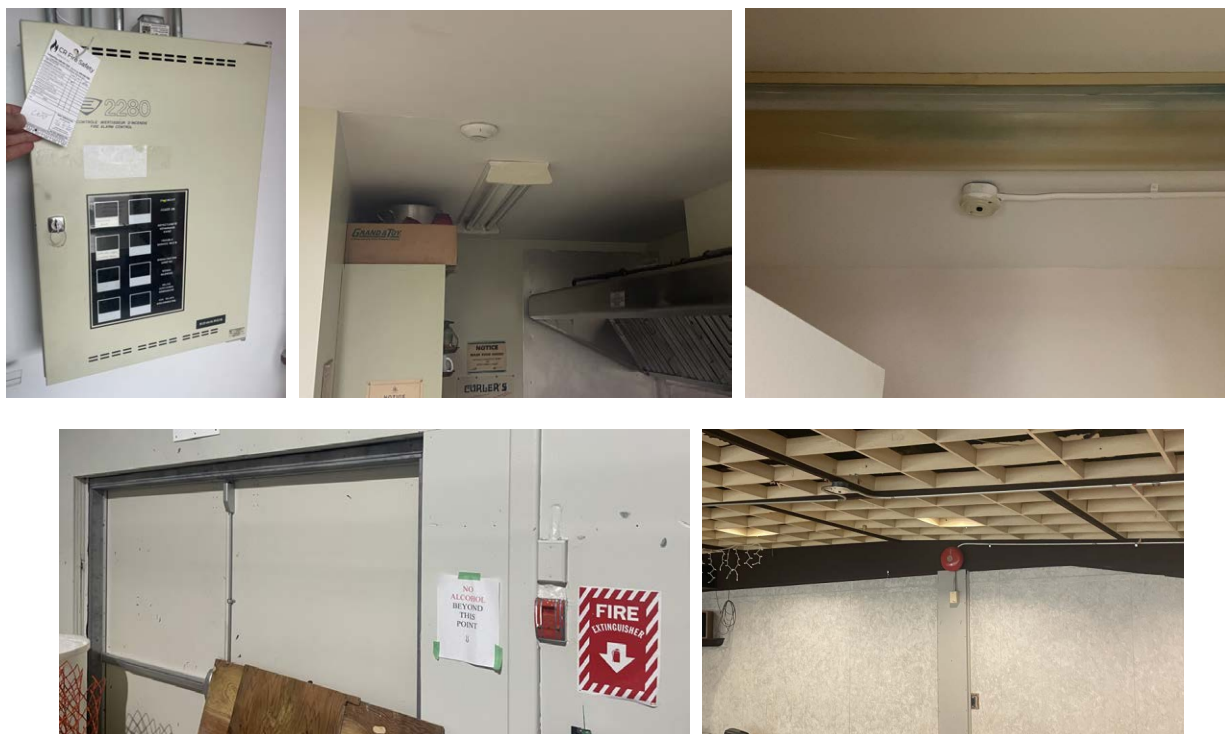
The existing fire alarm system is Edwards 2280, which comprises a fire alarm panel (no separate annunciator), manual pull stations, smoke detectors, heat detectors, and bells (see Figure 7). The height of all the manual pull stations does not comply with the latest BCBC requirements. Coverage of the fire alarm bells throughout the facility is inadequate, as per the latest BCBC requirements. It was also noted that there were no fire alarm strobes installed in any of the public corridors, washrooms and changerooms, as per the latest BCBC requirements.

Figure 7: Fire Alarm Panel & Examples of Fire Alarm Devices

- Arrange for a fire alarm verification to be taken place, which will identify any deficiencies, including failed devices, coverage, along with recommendations.
- Lower the height of all manual pull stations as per the latest BCBC requirements.
- Addition of fire alarm bells throughout the facility to ensure coverage as per the latest BCBC requirements.
- Addition of fire alarm strobes to the public corridors, washrooms and changerooms, as per the latest BCBC requirements.

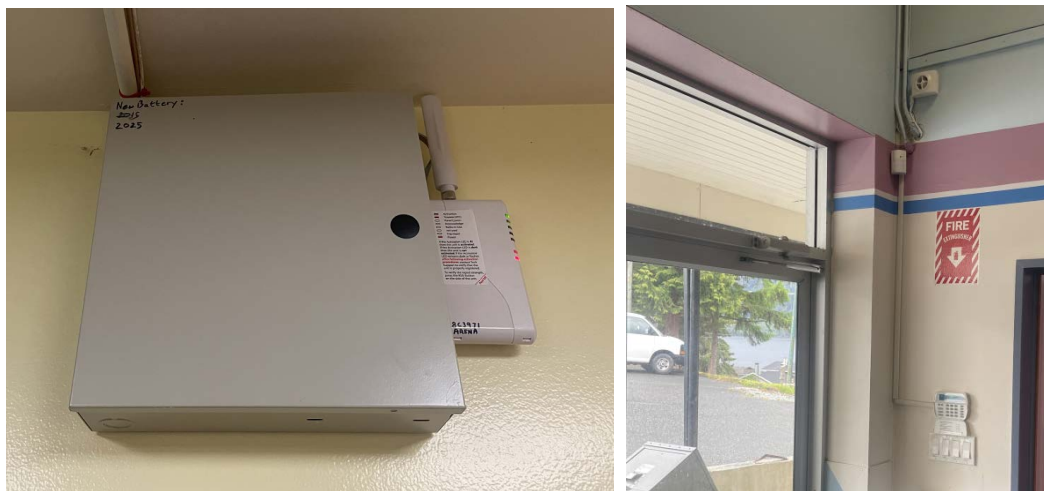
Security comprises of an intrusion detection system, of which there is a main panel, along with a keypad by the front entrance and PIR's located throughout the facility. Only one horn was spotted, which is located by the front entrance (see Figure 9).

**Figure 9: Intrusion Detection System**

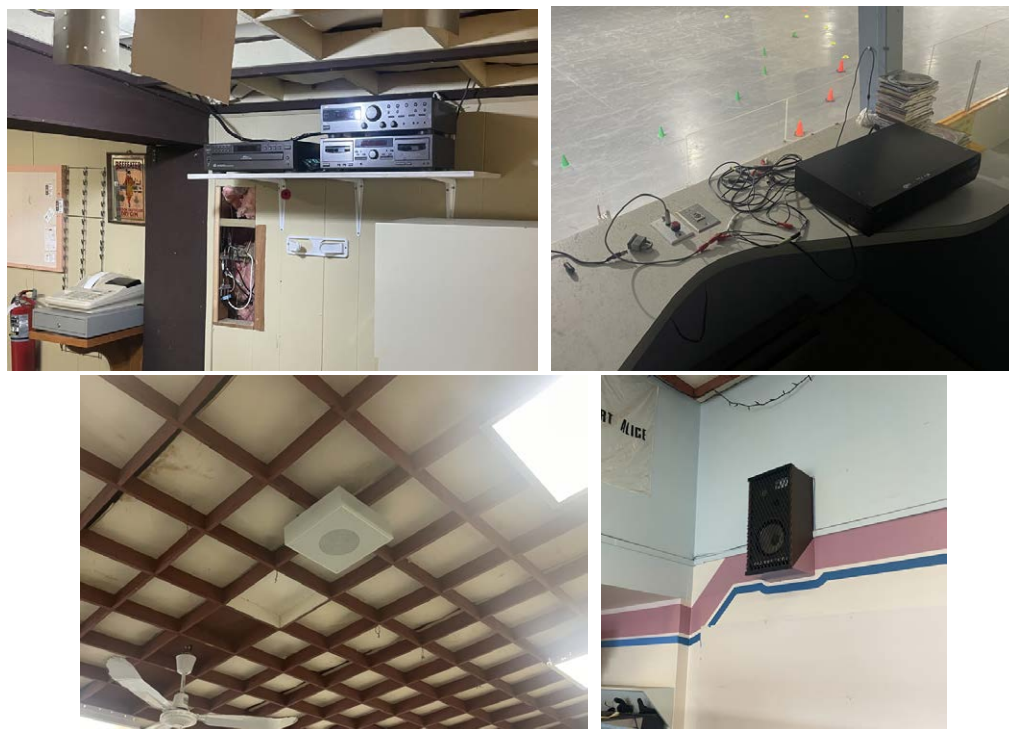
There are several locations where stand-alone PA systems have been installed complete with head end equipment (e.g. amplifiers), with each supported by different vintage speakers (see Figure 10). The functionality of this equipment was not verified at the time of site review; however, they appeared to be in reasonable condition. Speaker coverage appeared to be inadequate across the whole facility.

**Figure 10: Examples of PA System Components**

- Arrange for a test of the PA system(s) to ensure functionality of the head end equipment and speakers, which will identify any equipment deficiencies, as well as areas of the facility where speaker coverage is inadequate.

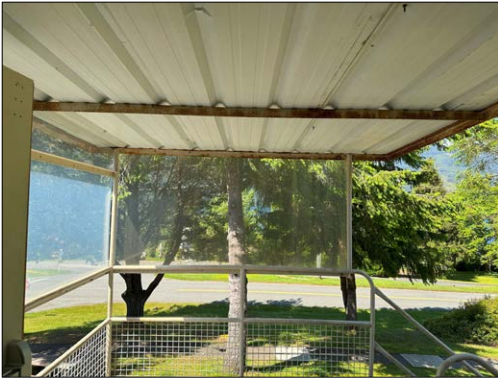
Photograph 1: Light rust to fire escape.

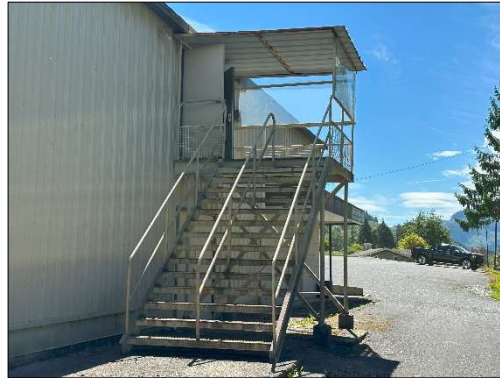
Photograph 2: Light rust to fire escape.

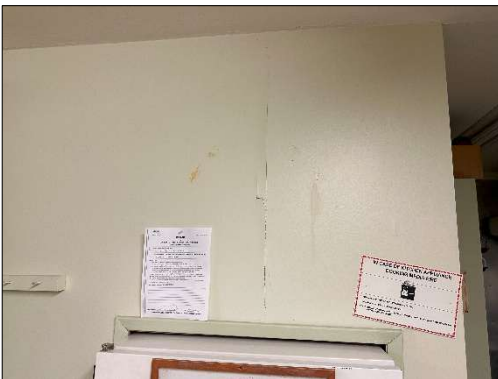
Photograph 3: Drywall cracking above fridge.

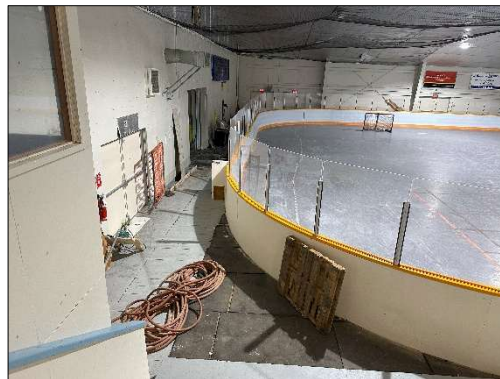
Photograph 4: Crack in ice slab indicating possible settlement.

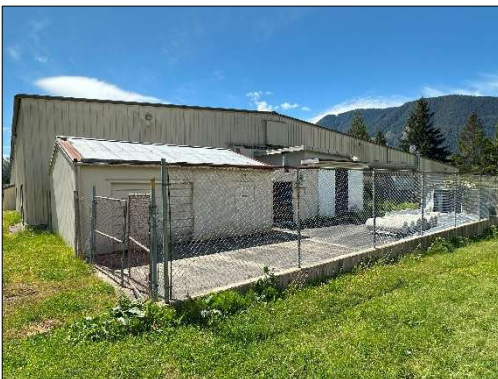
Photograph 5: Rust to roof cladding of shed.

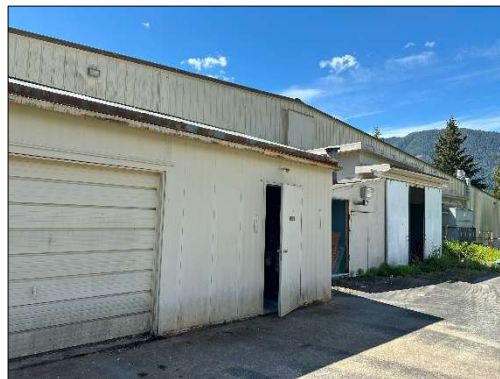
Photograph 6: Rust to shed cladding

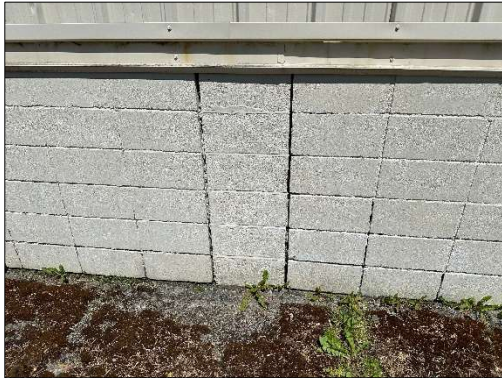
Photograph 7: Caulking missing at masonry foundation to north.

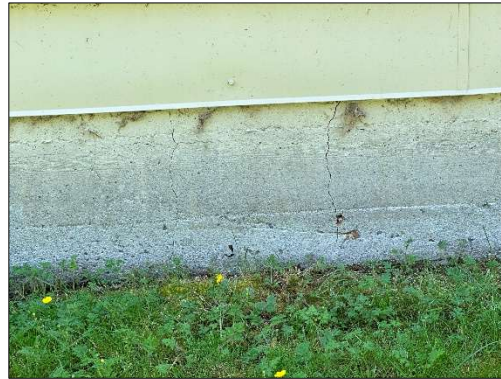
Photograph 8: Typical cracking to joints

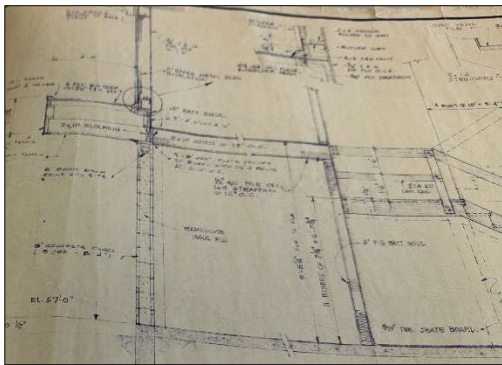
It was noted in a review of the original architectural drawings that vermiculite insulation is contained within the concrete masonry units of the fire wall.

Photograph 9: Note indicating vermiculite

- Engage a qualified professional for hazardous material testing if changes are proposed to the building that would include selective demolition and/or exposure of potentially hazardous construction materials.

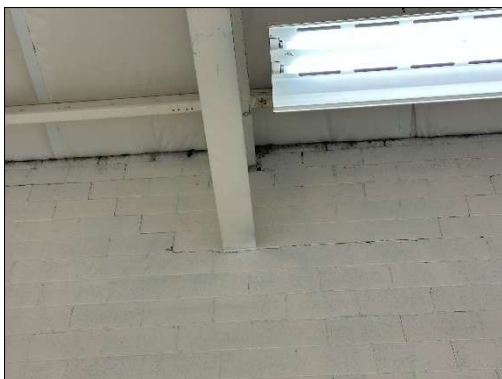
Photograph 11: Cracking to fire wall

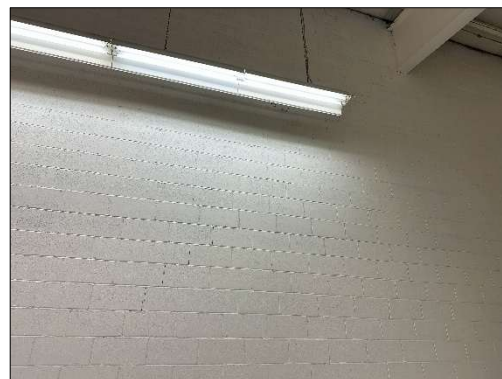
Photograph 12: Cracking to fire wall.
