### **MARINE DRIVE – PULP MILL BRIDGE**

#### **2024 BRIDGE INSPECTION**

February 8, 2024

Document Code: 24-003A2 Revision: R0

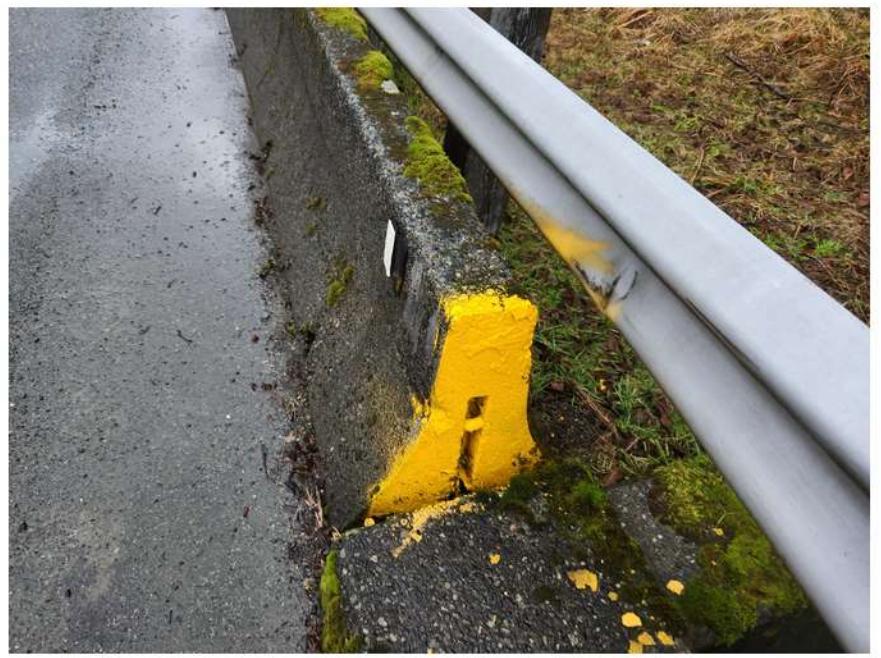
The concrete approach barriers are well cleaned with the end noses painted yellow. The barriers are not connected to the bridge barriers for continuity.

07 - Approach Barrier Connection

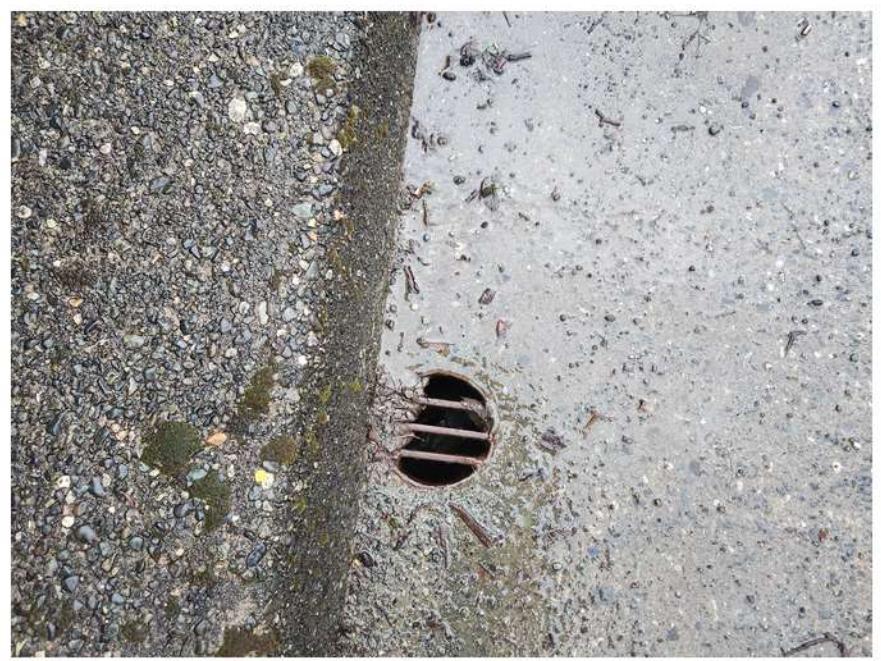
The bridge does not have an asphalt overlay, but the cast-in-place deck makes up the traveled surface and is in good condition. Deck drains are located throughout the structure on either side of the bridge adjacent to the elevated curb. At the time of inspection multiple deck drains were plugged with sediment, these drains partially cleaned during the inspection. Routine maintenance should be cleaning the deck drains and bearings.

06 - Deck Drain, Typ.

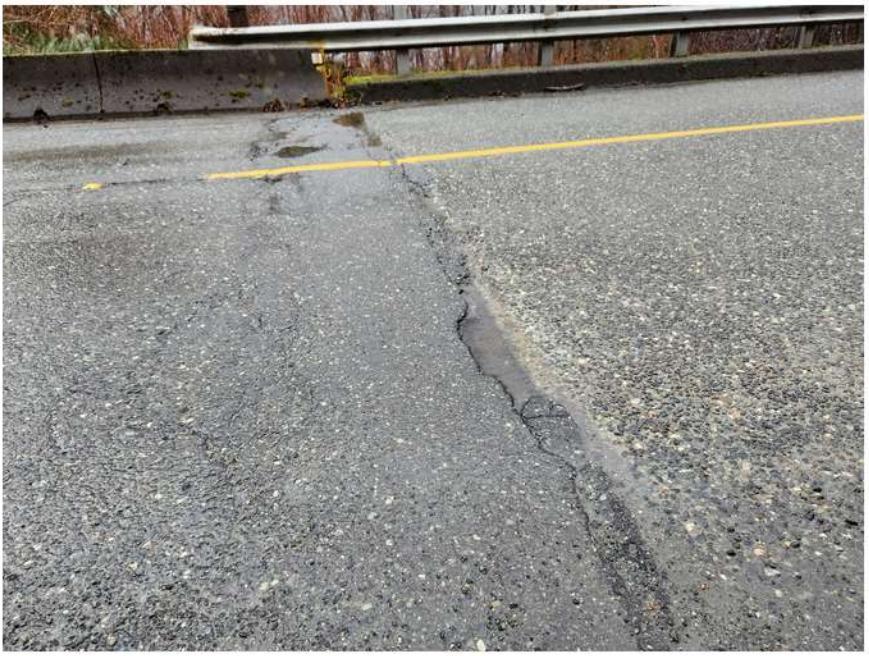
The bridge approaches consist of asphalt lane ways and a concrete bridge deck. The structure does not appear to have approach slabs, which is leading to asphalt failure at the ends of the bridge deck. Expansion joints are not visible at the ends of the bridge and appear to have asphalt paved to the concrete deck. This asphalt at the concrete deck joint is deteriorating and breaking away. Asphalt patching compound should be added at the ends of the bridge to prevent spalling of the concrete deck.

08 - Deck Joint, Typ.

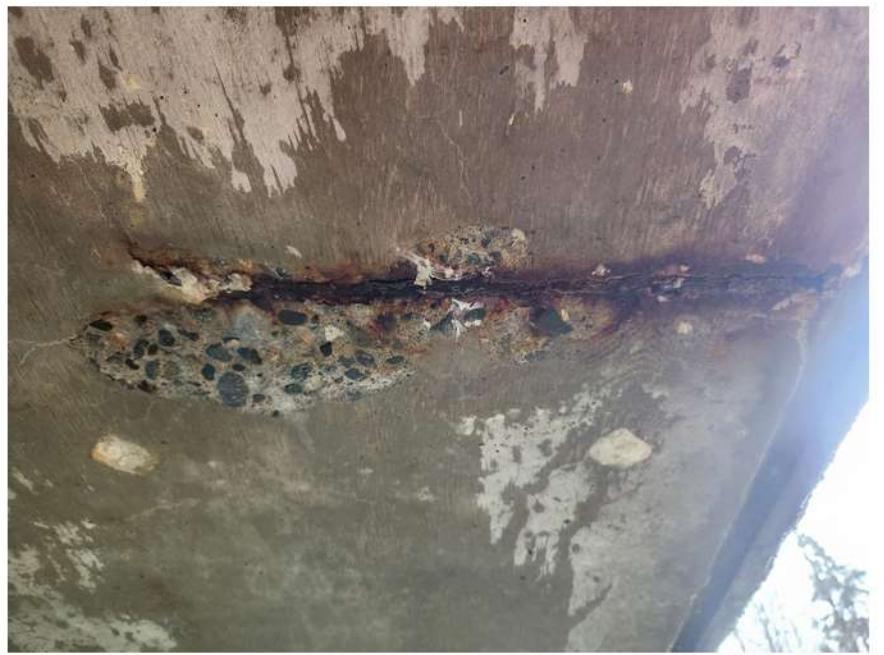
On the downstream side of bridge, 3m from the south abutment exposed rebar was noted on the sofit of the cantilevered portion of the deck, this rebar has begun to corrode and spall concrete along the length of corrosion. This should be repaired to prevent further rebar corrosion and concrete spalling.

10 - Rebar Corrosion

3	Installed standard MOTI delineators	Moderate
4	Repair asphalt and ends of bridge at concrete deck	Moderate
5	Clean and repair exposed rebar on underside of deck	Moderate
6	Clean, prepare and re-coat bearing plates	Low

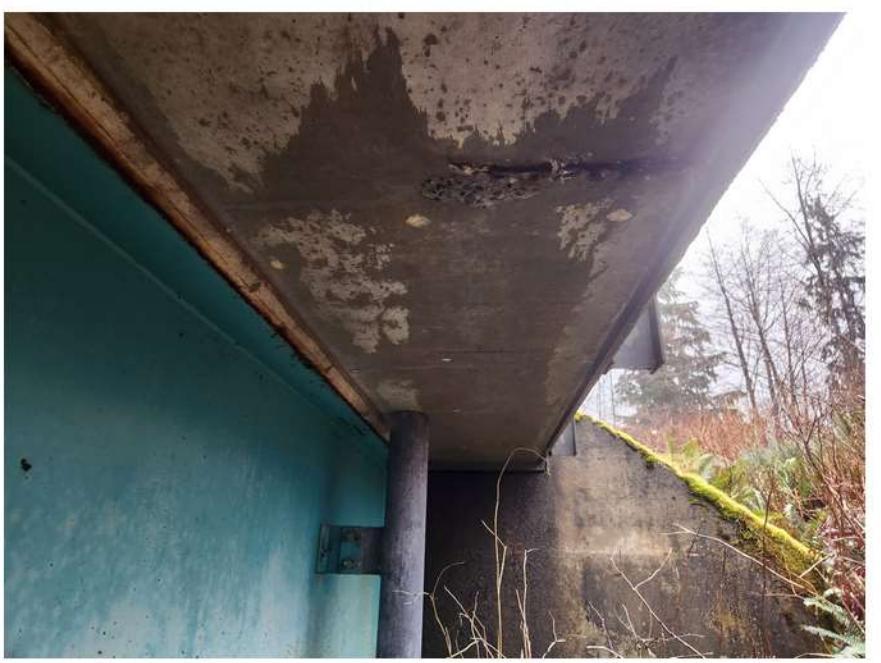
09 - Rebar Corrosion

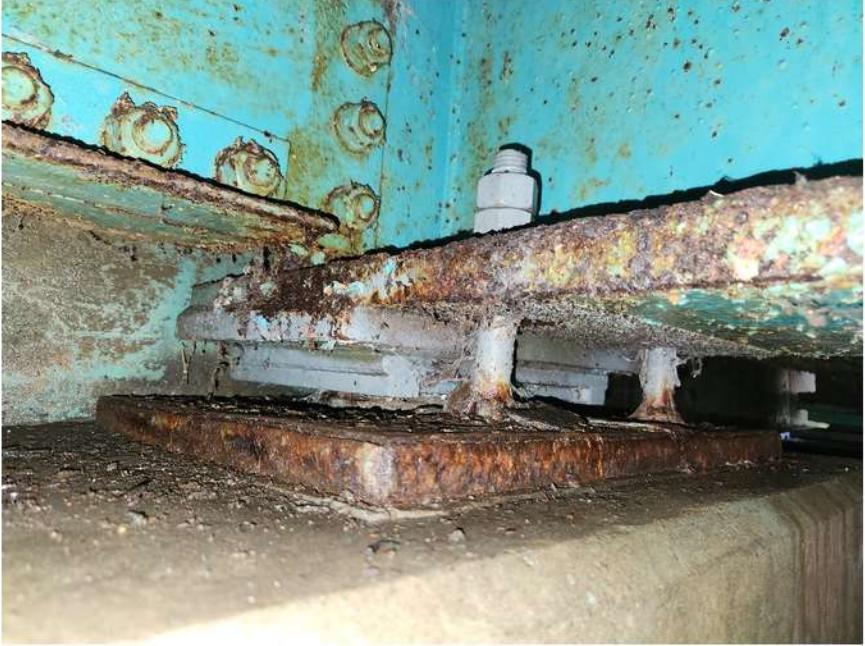
The bearing masonry and sole plates are poorly coated with exposed steel. The exposed steel is rusting and starting to flake of coating and steel material. These steel plates should be sufficiently cleaned, prepared, and re-coated to prevent bearing replacement or further corrosion.

12 - Typical Bearing Corrosion

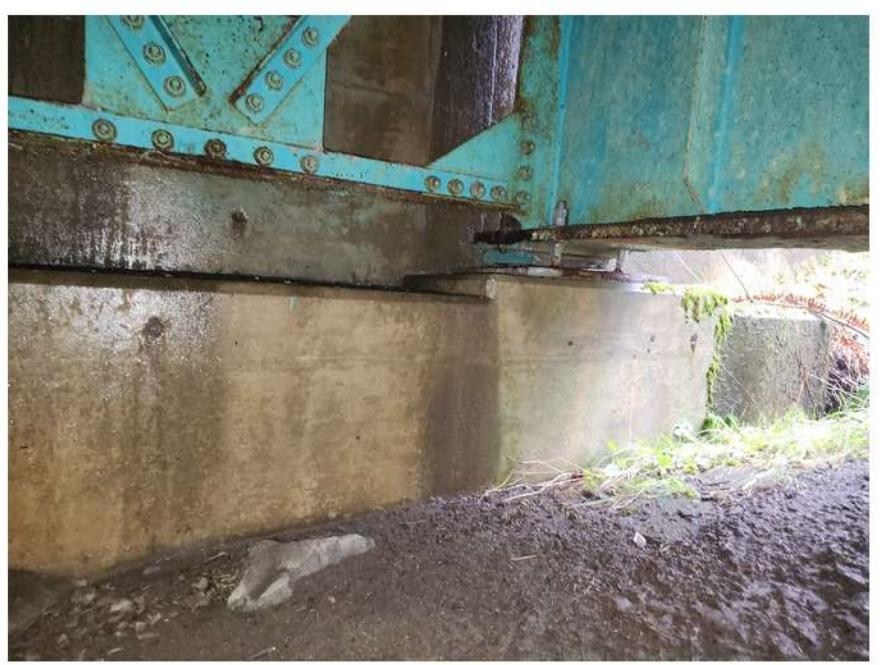
Both abutments consist of cast-in-place concrete on what appears to be intact bedrock. No signs of cracking or settlement were noted during the inspection. The bridge bears on pot bearings and concrete plinths, with an integrated concrete headwall. No lateral shear keys are present, the bearings are secured laterally with embedded steel dowels that are likely insufficient for seismic loading.

12 - Typical Bearing

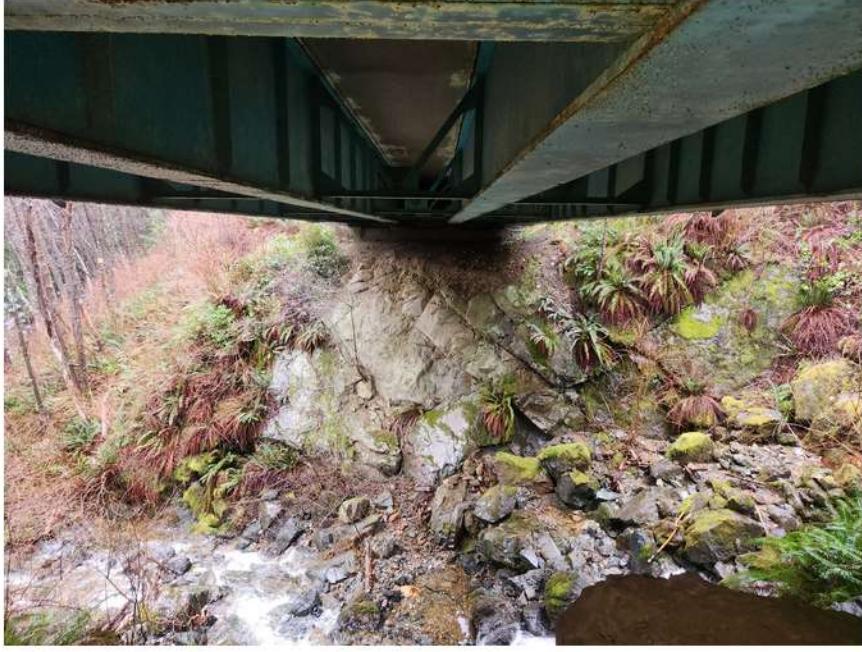
14 - North Abutment

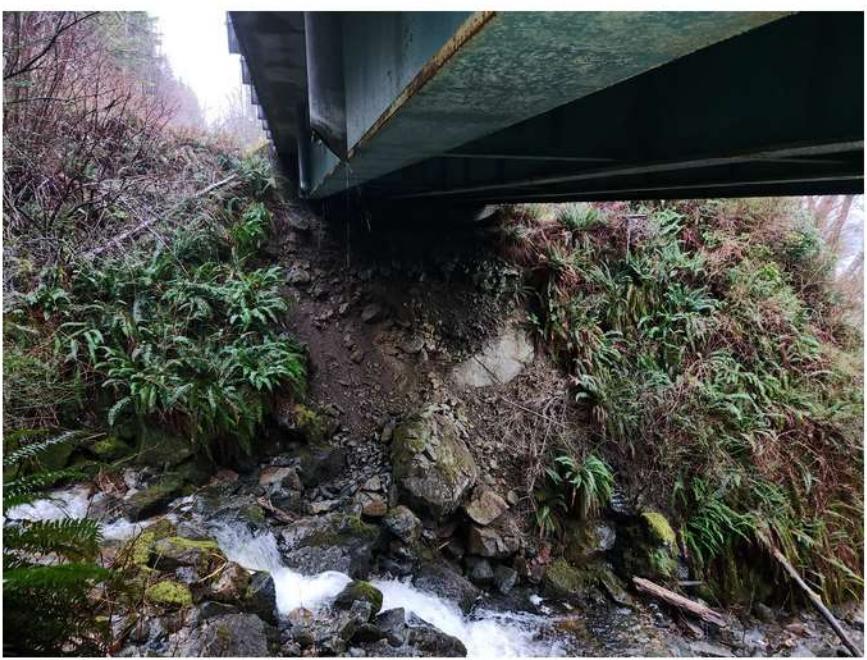
15 - South Abutment

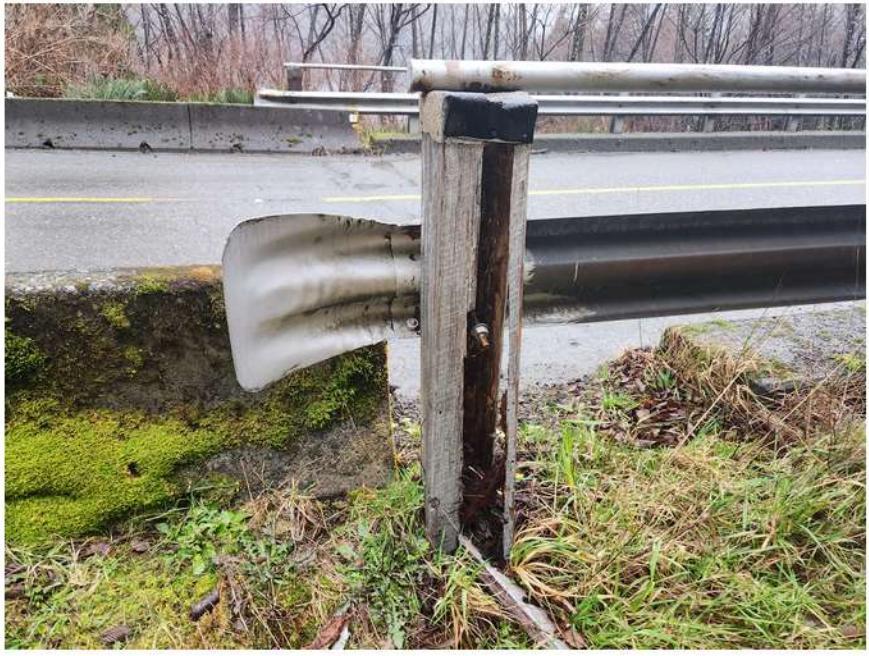
Timber end posts for the W-beam barrier railing are rotten and should be replaced.

17 - Rotten End Posts

Table 1 – List of Maintenance / Repair Items				
Item No. Description Price				
1	Replace timber end posts for barrier railing	Moderate		
2	Clean deck and drains of sediments	Low
