### **MARINE DRIVE – PULP MILL BRIDGE**

#### **2024 BRIDGE INSPECTION**

February 8, 2024

Document Code: 24-003A2 Revision: R0

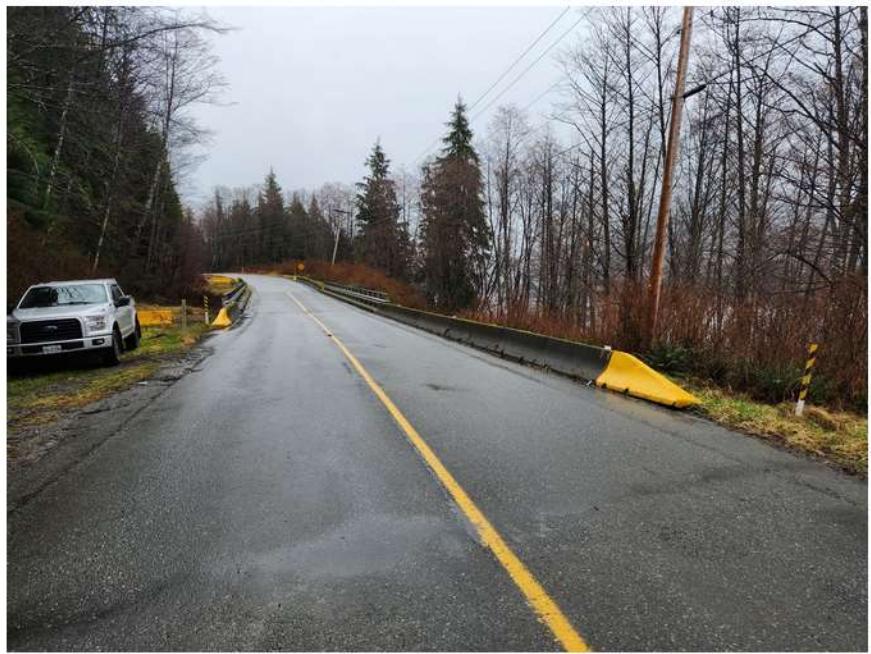
01 - Approach from North Facing South

The bridge approaches consist of asphalt lane ways and a concrete bridge deck. The structure does not appear to have approach slabs, which is leading to asphalt failure at the ends of the bridge deck. Expansion joints are not visible at the ends of the bridge and appear to have asphalt paved to the concrete deck. This asphalt at the concrete deck joint is deteriorating and breaking away. Asphalt patching compound should be added at the ends of the bridge to prevent spalling of the concrete deck.

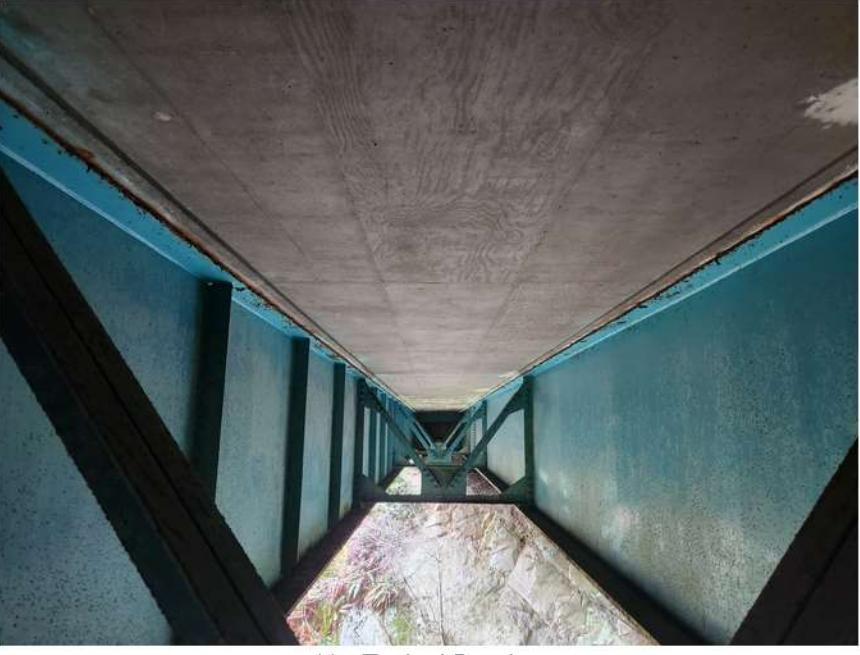
The girders and bracing are generally in good condition. On average, it was estimated 95% of the coating is remaining, with surface staining and portions of the flanges starting to corrode. The bridge is currently 45 years old which has likely exceeded the expected service life of the coating. The type of coating system is unknown, but the rate of coating loss should be monitored.

11 - Typical Bracing

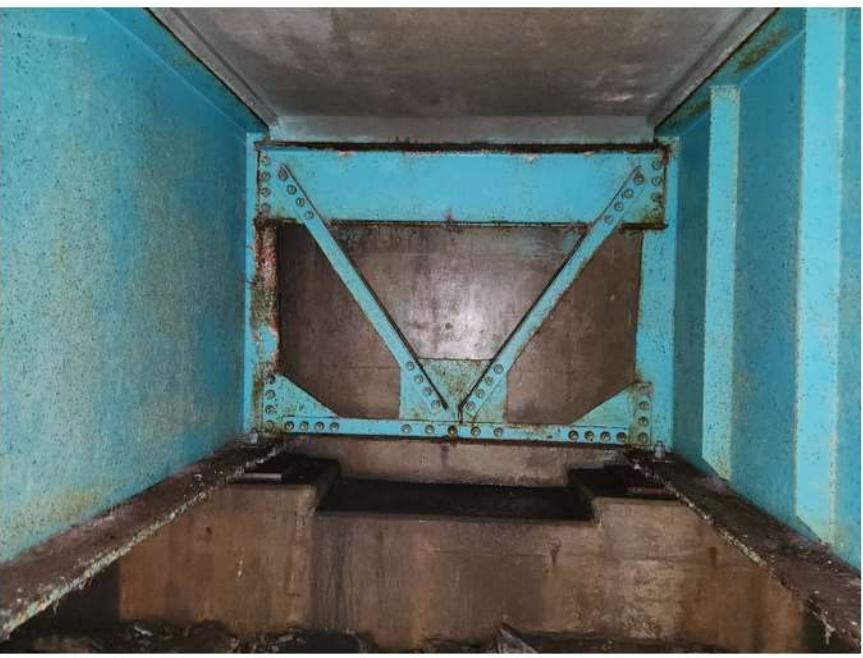
13 - Typical Diaphragm

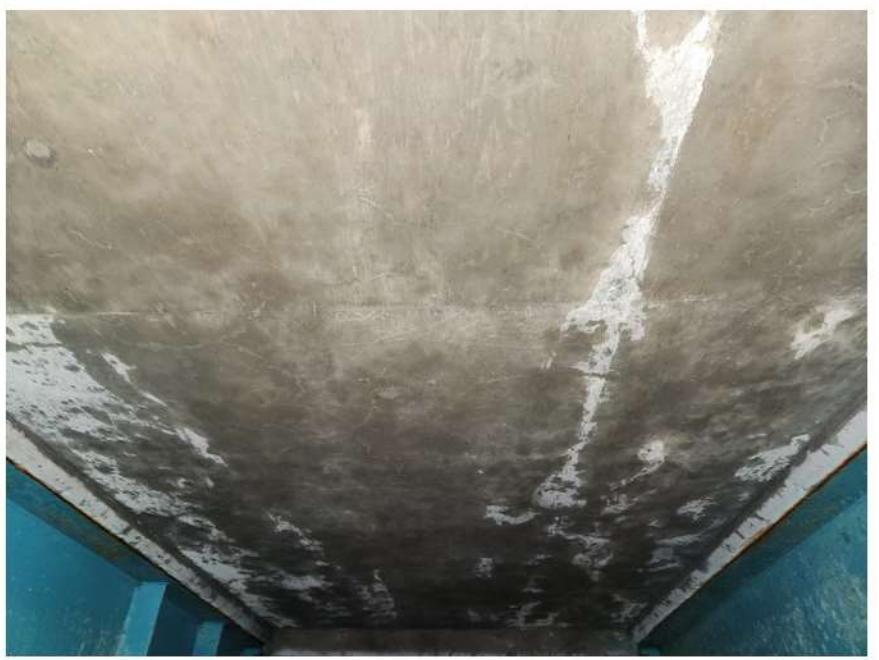
The bridge does not have an asphalt overlay, but the cast-in-place deck makes up the traveled surface and is in good condition. Deck drains are located throughout the structure on either side of the bridge adjacent to the elevated curb. At the time of inspection multiple deck drains were plugged with sediment, these drains partially cleaned during the inspection. Routine maintenance should be cleaning the deck drains and bearings.

16 - Typical Underside of Deck
