## Building Condition Assessment

# Port Alice / Doug Bondue Arena

05 November 2025

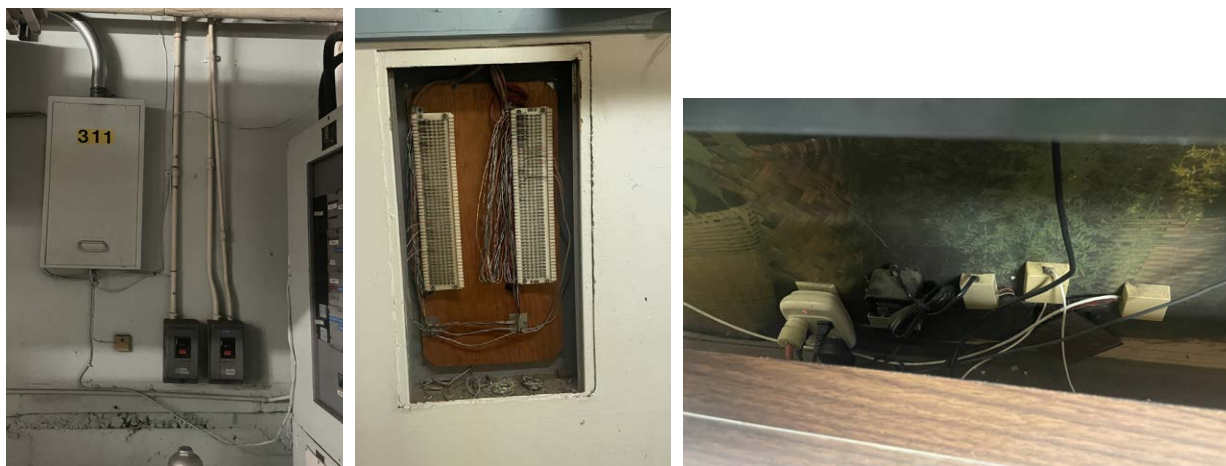
**Figure 8: Telus Demarcation, Telephone / Data Tie In, & Telephone / Data Outlet Examples**

The telephone and data service for the facility is an overhead & underground Telus service terminating in the Mechanical / Electrical Room. There are wall mounted data outlets in the office and skate rental areas, which run back to the tie-in location (see Figure 8).
